**White Stadium
Boston, MA**

Tree Preservation Report

Andrew Balon
Arborist Representative
ISA Certified Arborist
ISA Tree Risk Assessment Qualified
50 Bear Hill Rd,
Waltham, MA 02451
(781) 622 5980

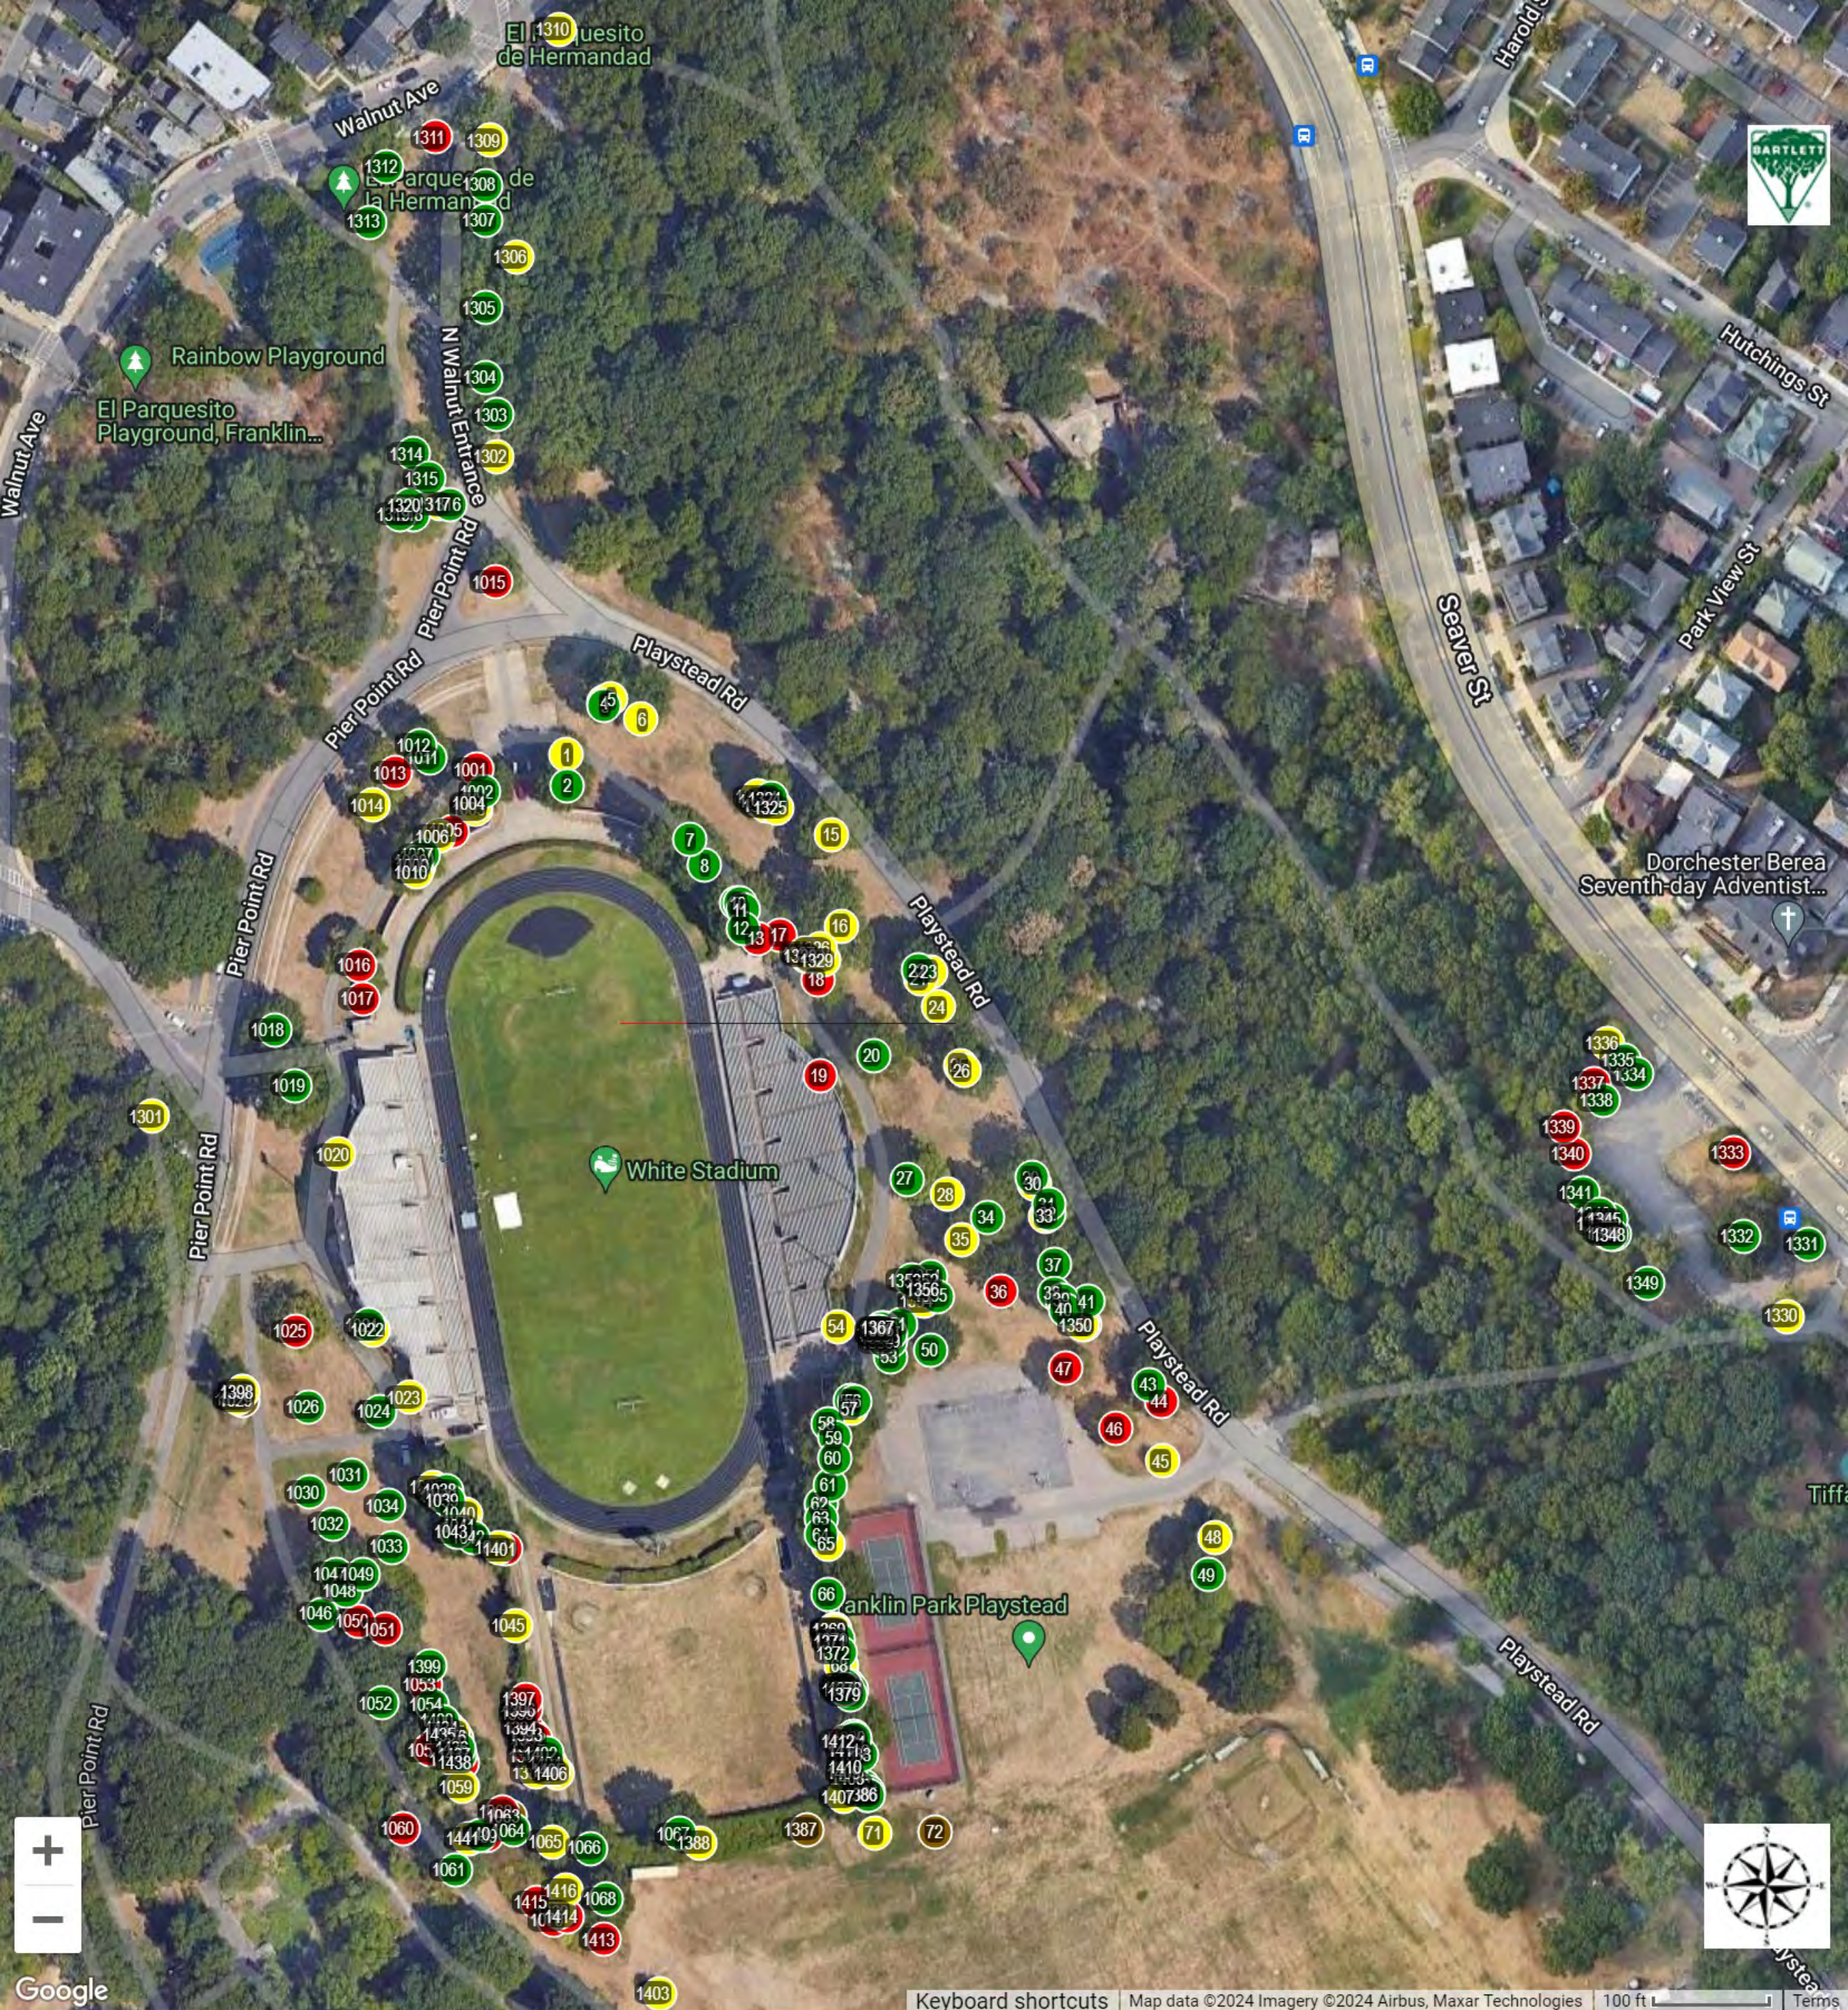
Condition: ● Good ● Fair ● Poor ● Dead

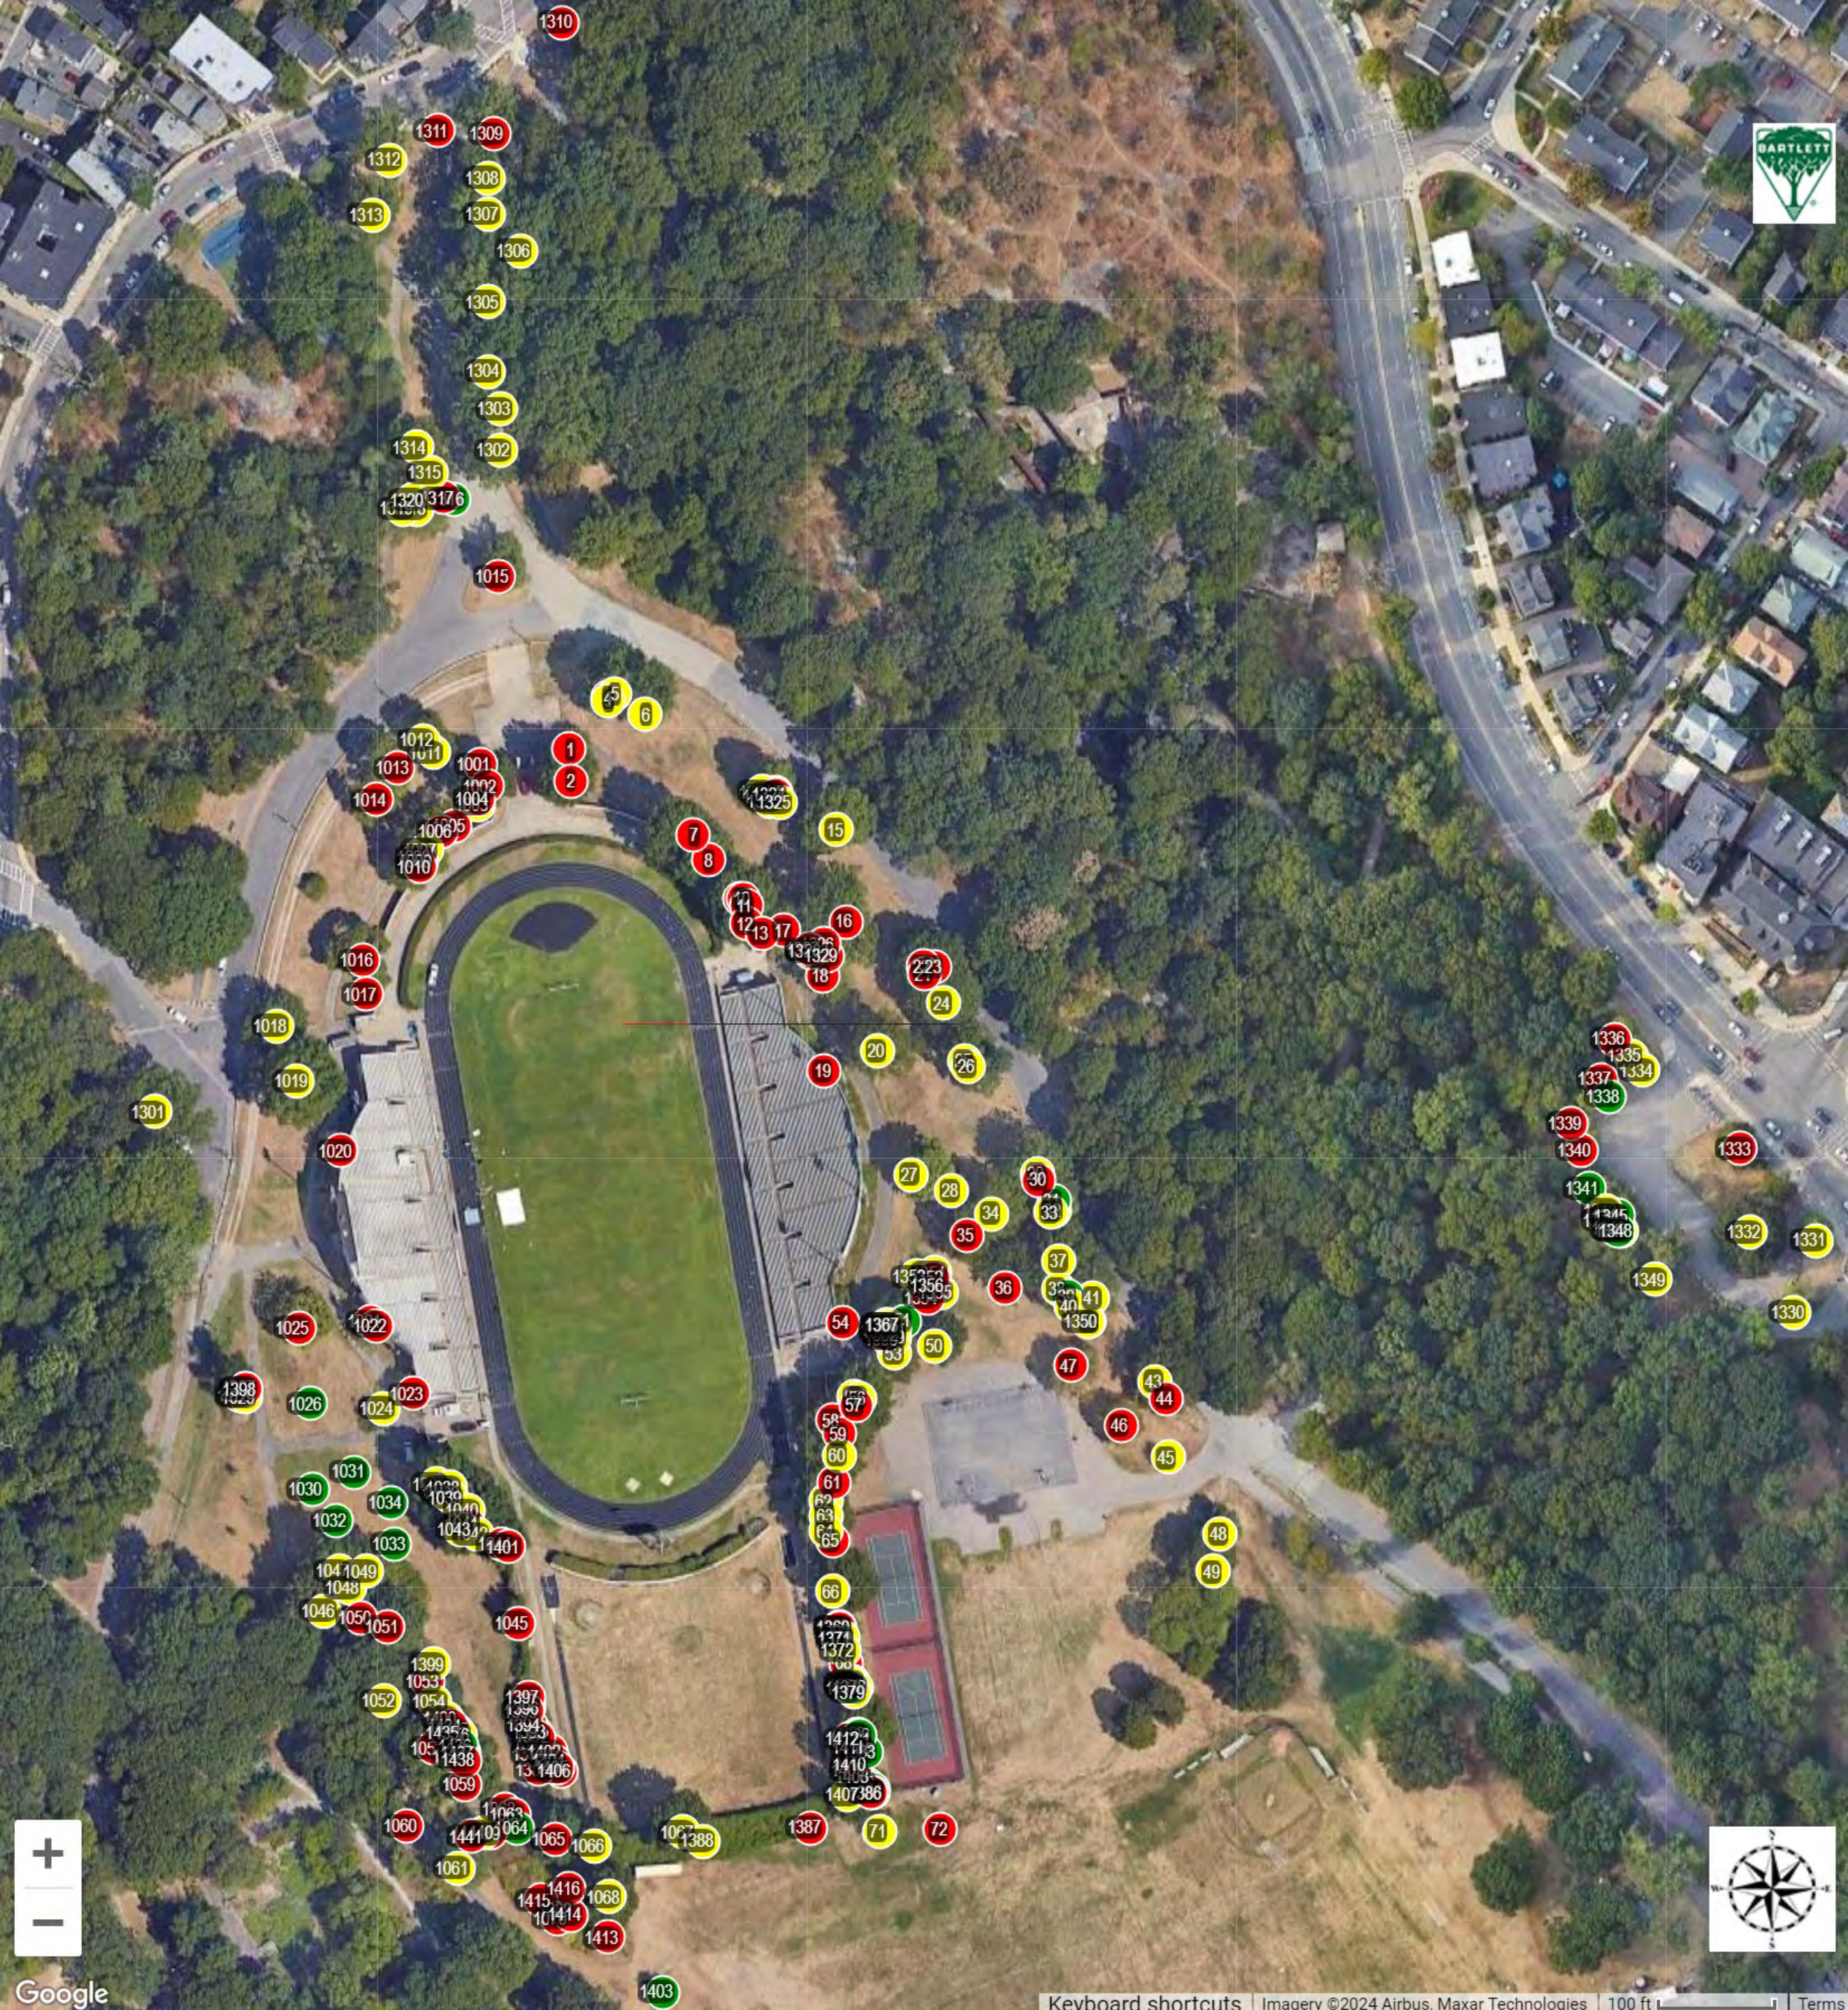
Suitability for Preservation: ● High ● Moderate ● Low

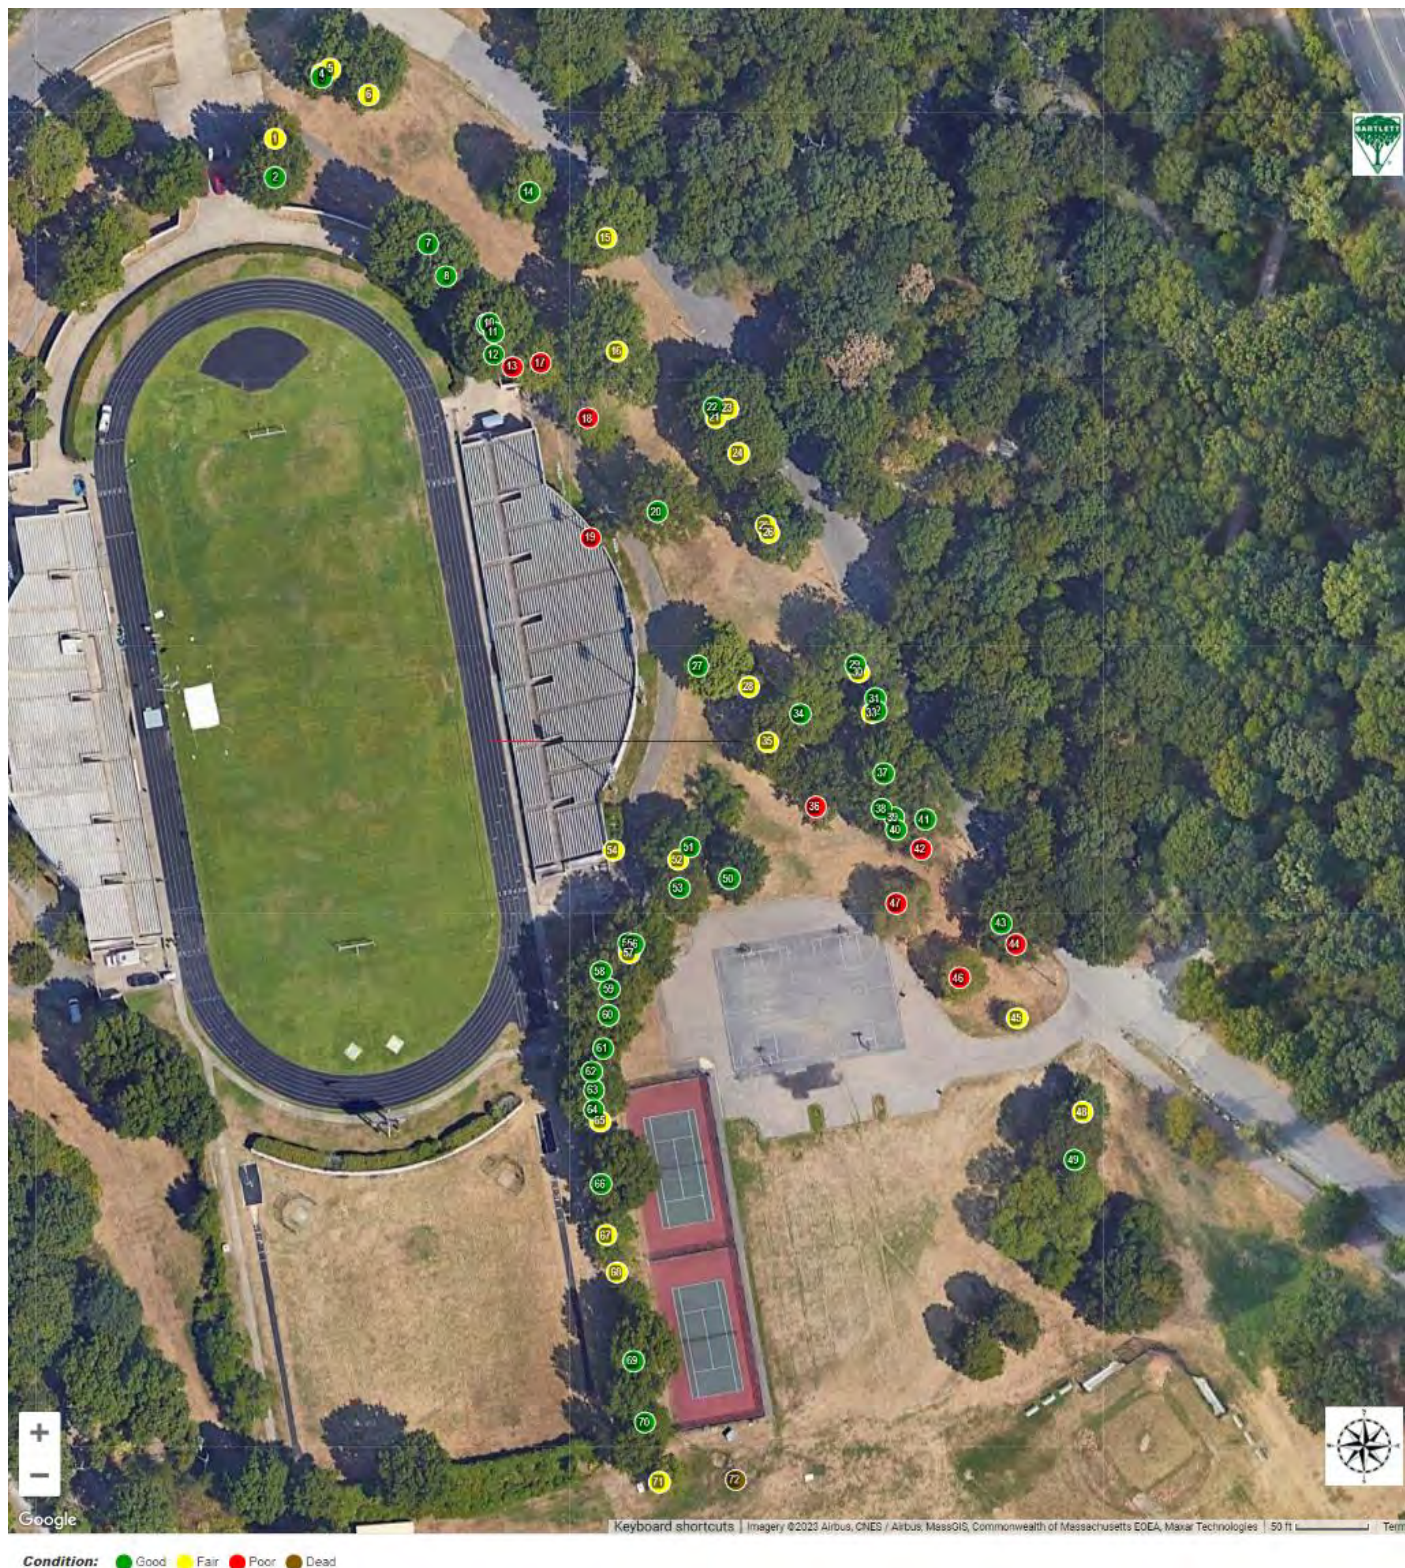
Map 1. Condition map generated using the Arboscope program. This map shows all trees included in this report and their assigned condition classes recorded during the site visit on December 14, 2023.

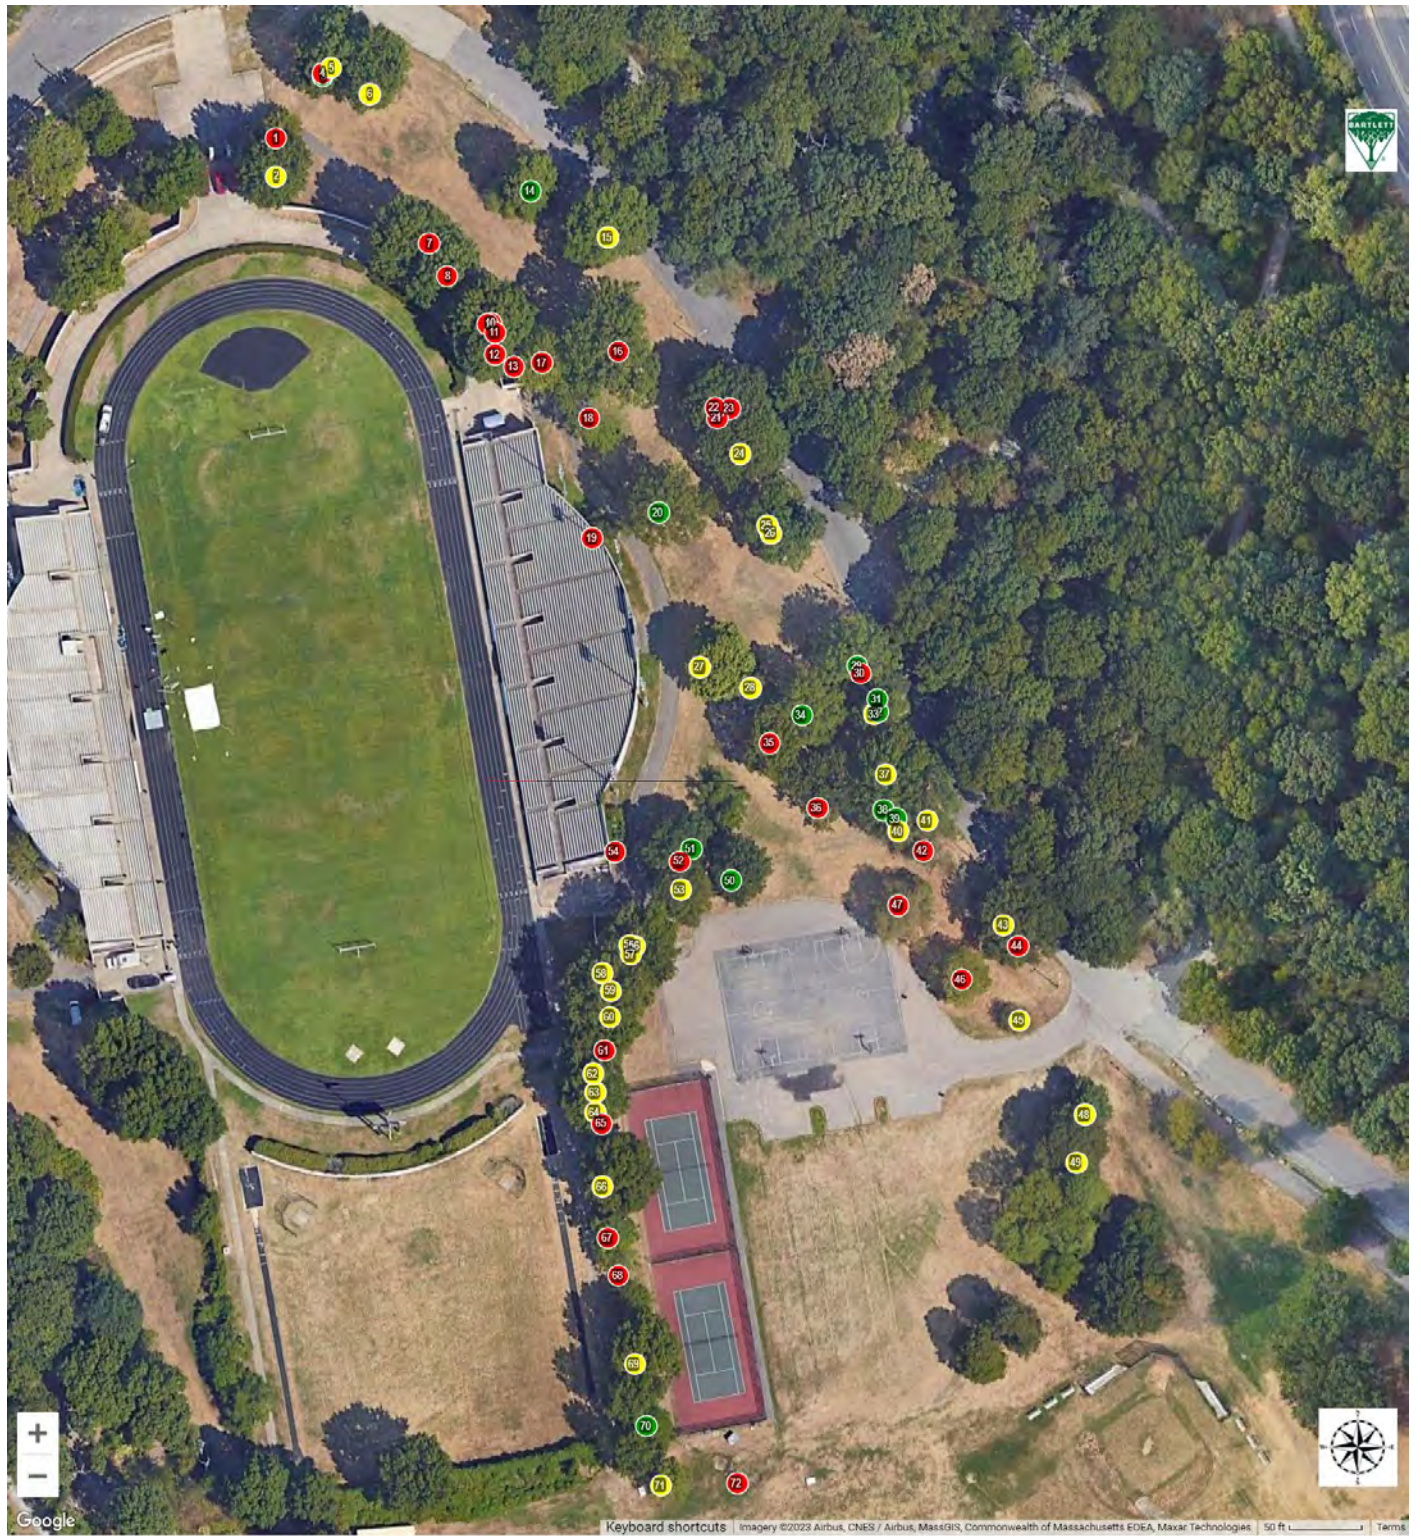
Map 2. Suitability for preservation map generated using the Arborscope program. This map shows all trees included in this report and their assigned suitability for preservation rating recorded during the site visit on December 14, 2023.

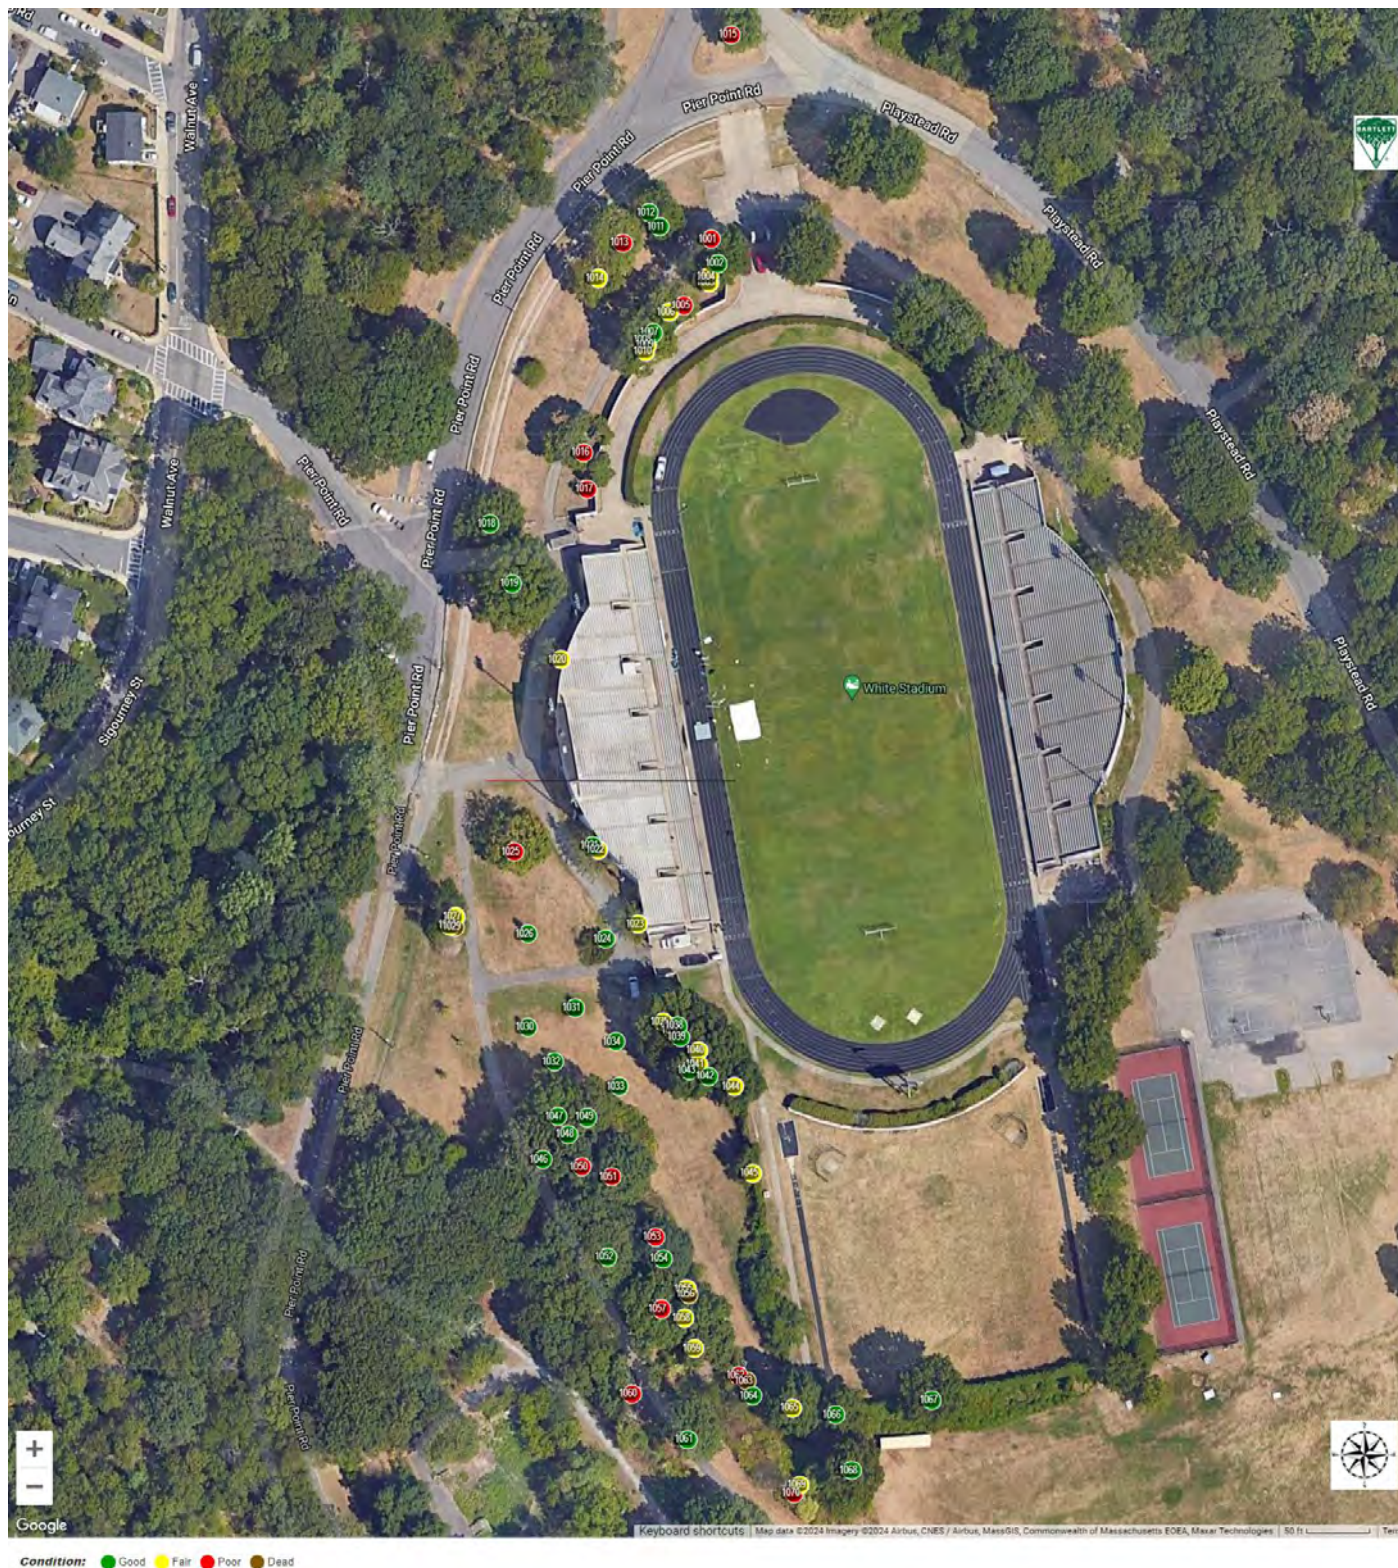
Map 1. Condition map generated using the Arborscope program. This map shows all trees included in this report and their assigned condition classes recorded during the site visit on April 15, 2024.

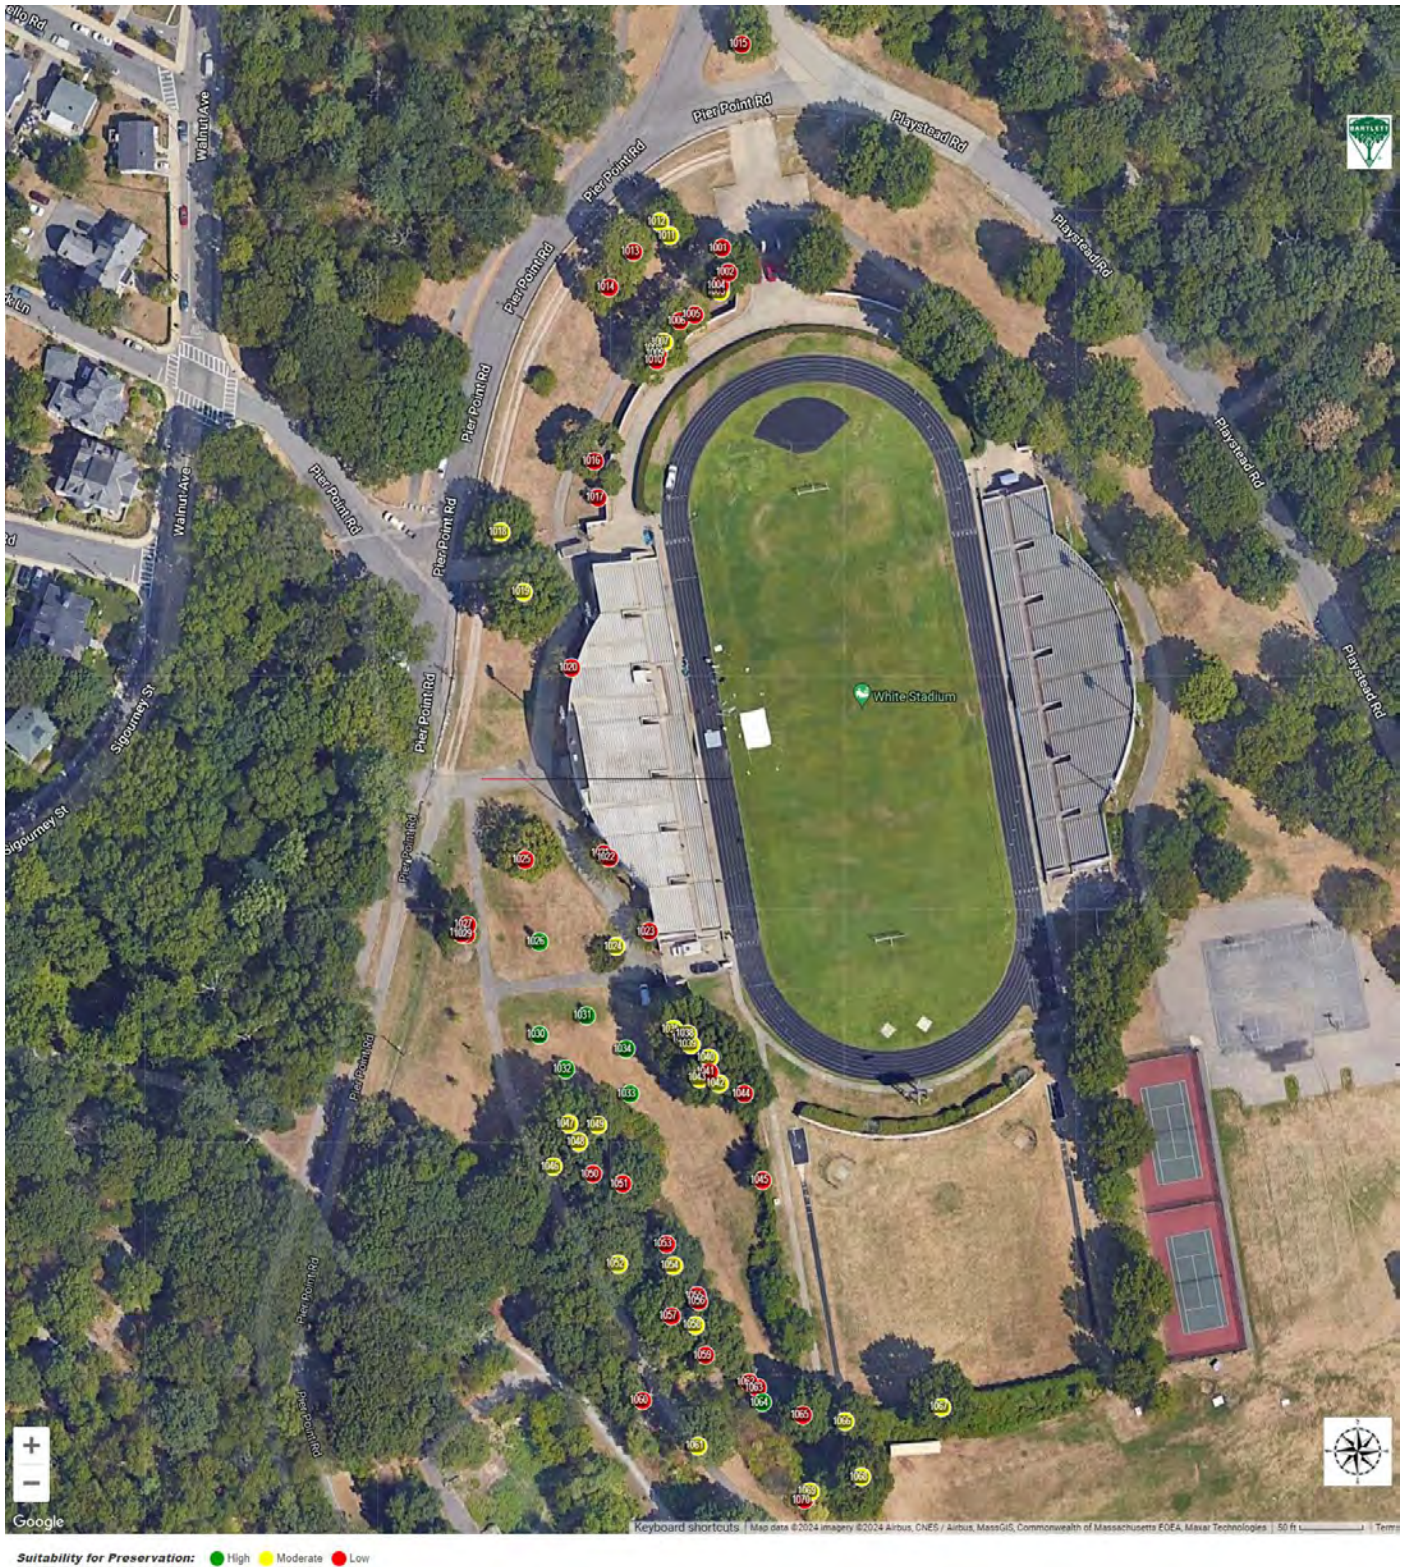
Map 2. Suitability for preservation map generated using the Arborscope program. This map shows all trees included in this report and their assigned suitability for preservation rating recorded during the site visit on April 15, 2024.
