A Review of the Application to
Remove the Crossbar Framing the Parking Area
183 Comm Ave and Public Alley 425

BBAC Public Hearing
Case 18 369 BB

December 13, 2017

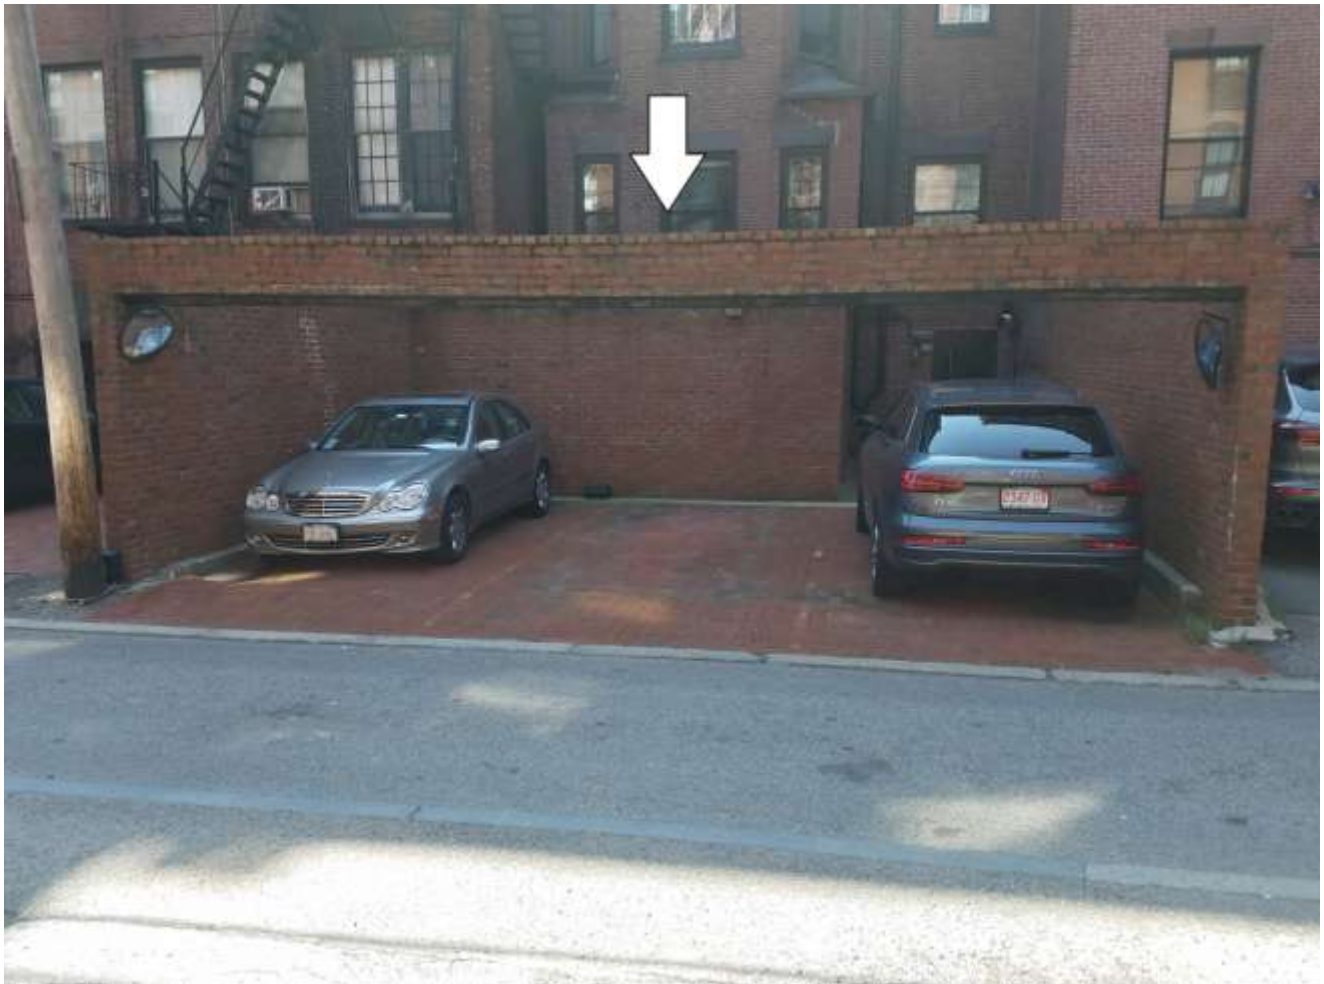
The enclosed parking area is framed by a crossbar that frames the entrance facing Public Alley 425.

Photo below looks south across Public Alley 425 to the rear of 183 Comm Ave.

The crossbar is 7 feet high and prevents boom lift and other trucks from entering the parking area.

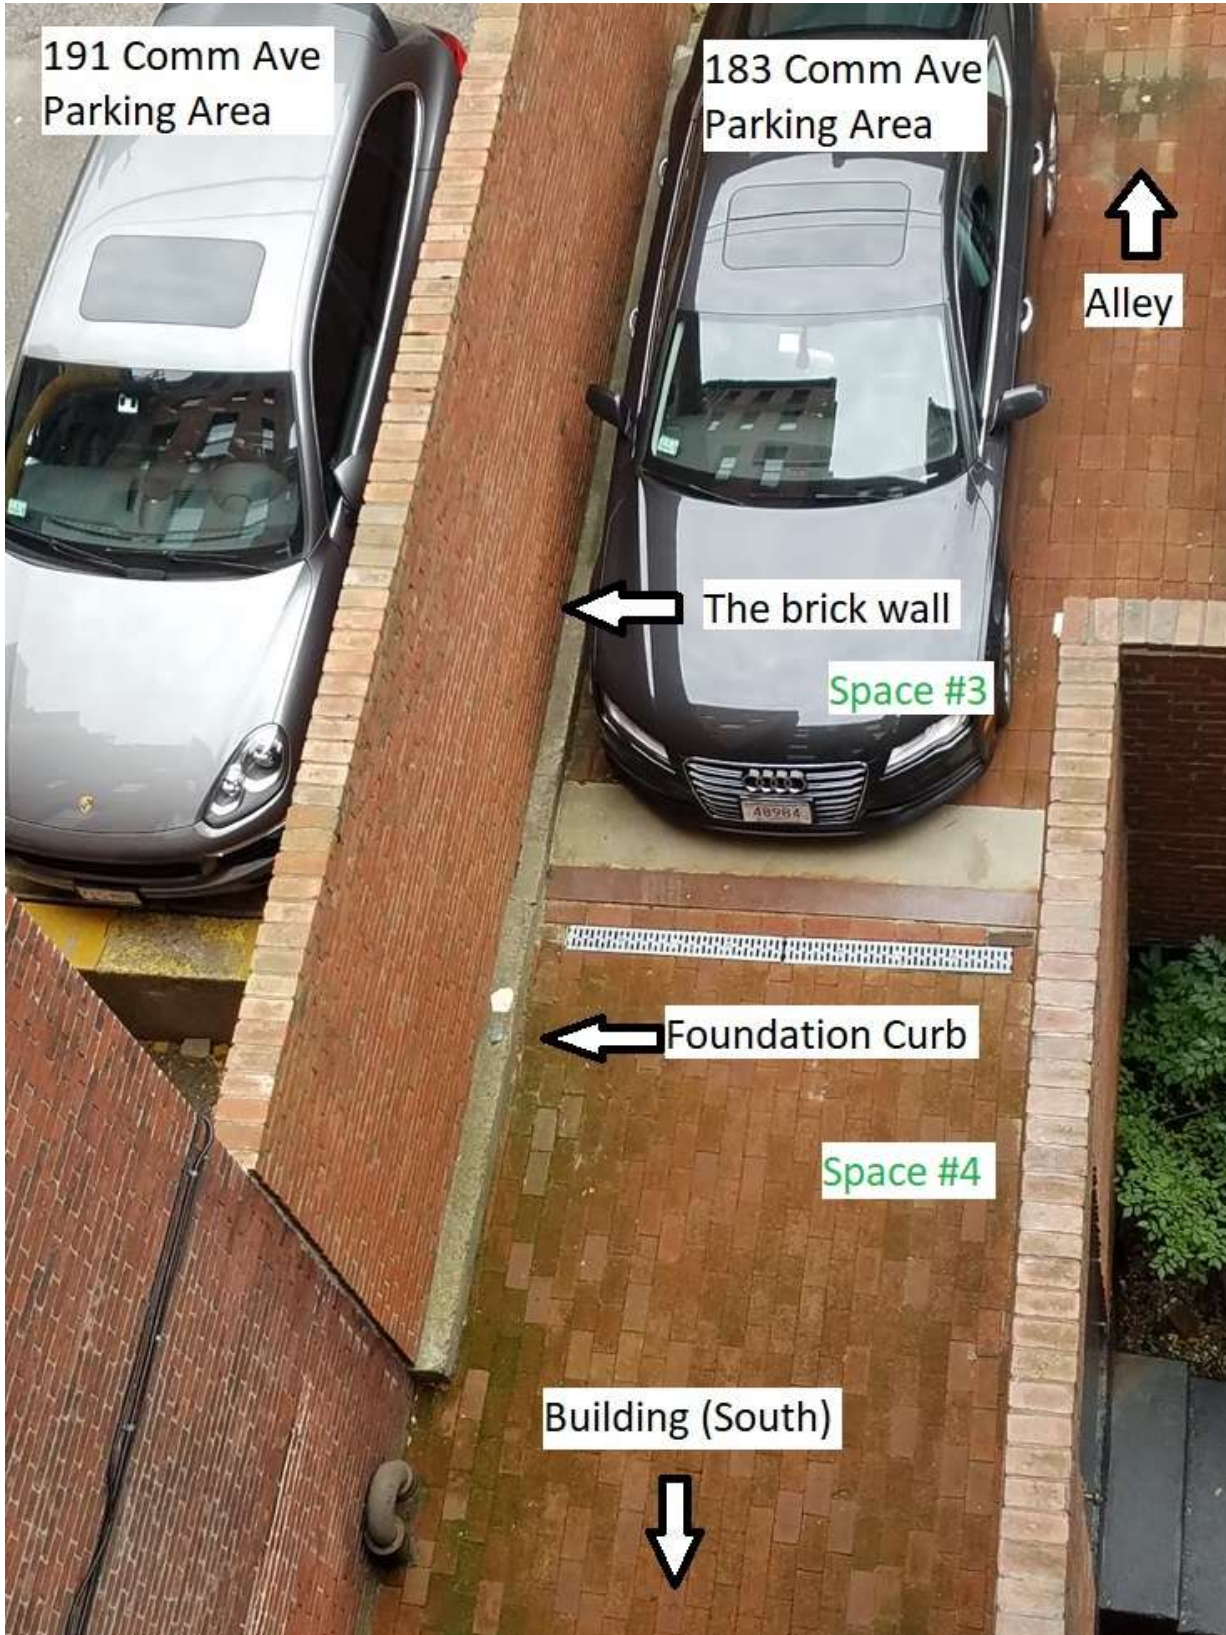
AERIAL VIEW OF THE PARKING AREA

The brick wall separating the 183 and 191 parking areas (pictured) is 7 feet 8 inches high and 18 feet 6 inches long.

Photo taken from 183 Comm Ave. Public Alley 425 is at the top (north) and 183 Comm Ave is at the bottom (south).

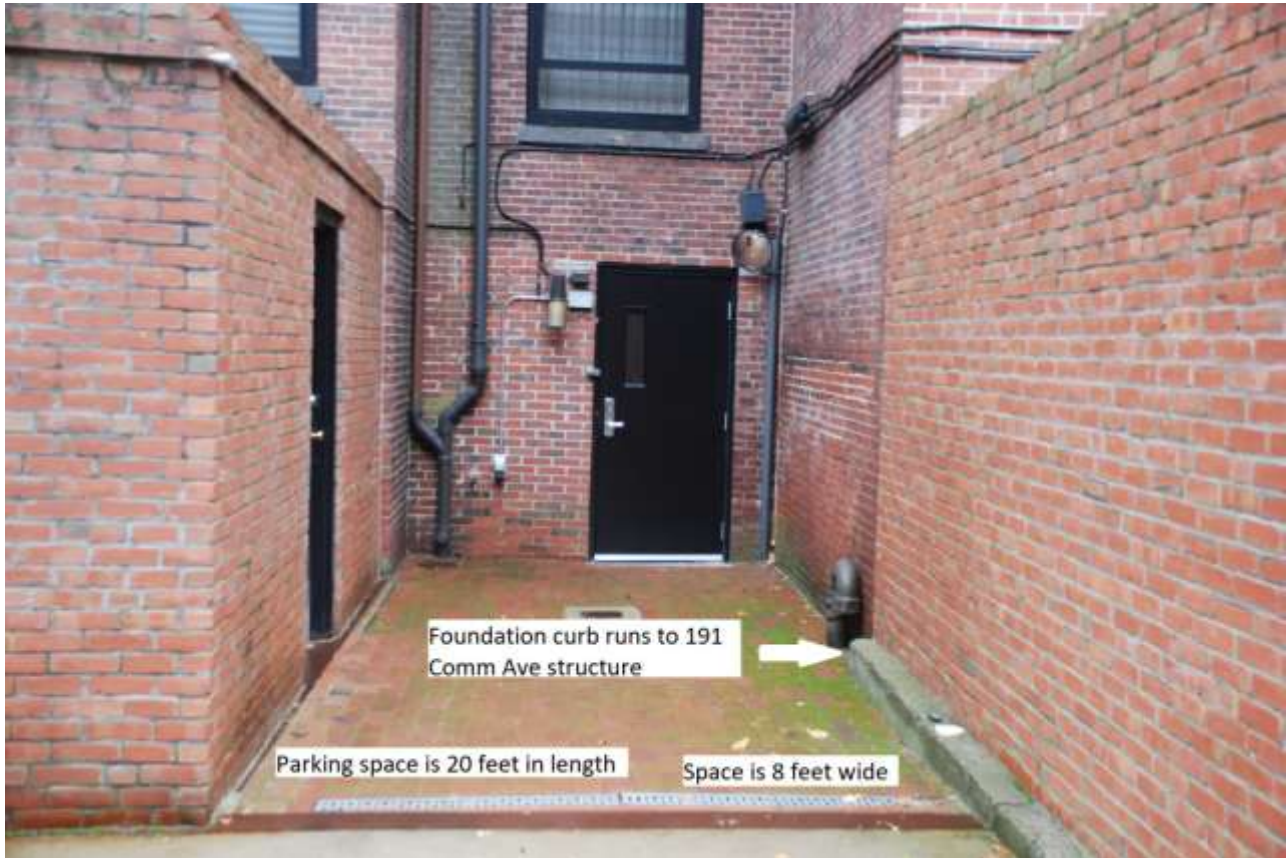
THE 183 PARKING AREA IS FLAT AND AT THE BASEMENT LEVEL

The 183 Comm parking area is comparatively flat.

The window above the black door belongs to Unit 2 which is considered the ground level of 183 Comm Ave.

This photograph is taken while standing in Public Alley 425 looking at the rear of 183 Comm Ave.

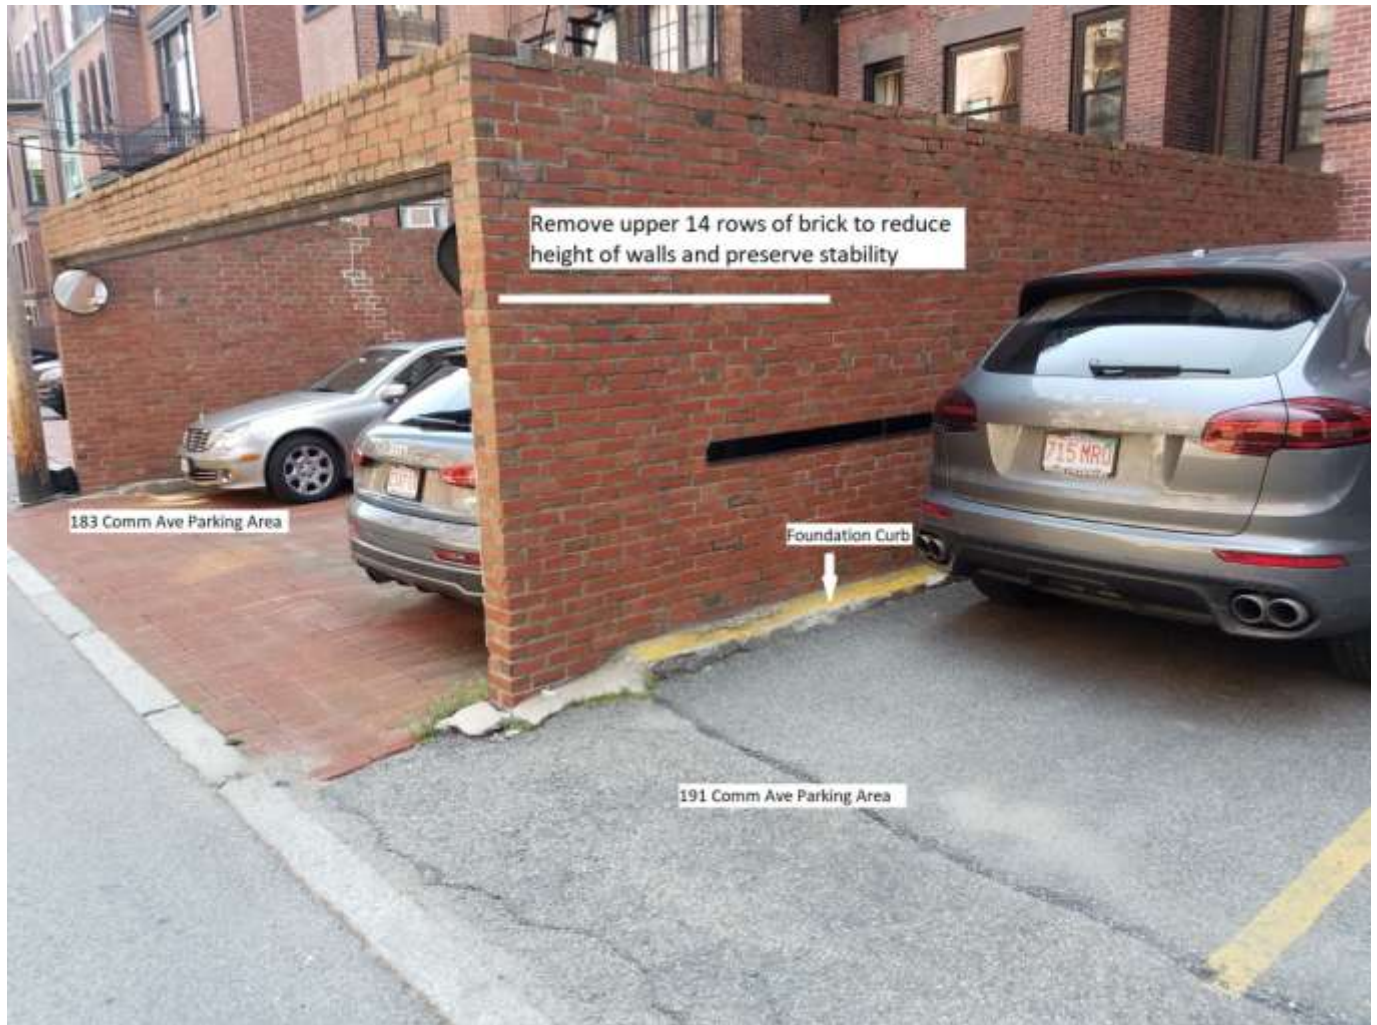
PHOTO SHOWING HOW THE HEIGHT OF THE SIDE WALL WOULD BE LOWERED

The horizontal white line in the photograph below shows the height of the wall between 183 and 191 parking areas if 14 rows of bricks are removed.

At the request of the BBAC, a course of blue stone 2 inches thick would be added on top to finish the brick wall.

The height of the wall including the blue stone cap would be 67 inches or just over 5½ feet.

This picture is taken while standing in Public Alley 425 facing east. In the foreground is the parking area of 191 Comm Ave. In the back half of the photo is the parking area of 183 Comm Ave. Beyond that is the 181 Comm Ave parking area.

NB: The photograph also provides perspective on the height difference between the two parking areas. The height difference necessitates the concrete footer that the mason does not want disturbed or compromised.

The mason advises that the height of two side walls be lowered by approximately 1/3 by removing 14 rows of bricks (this would lower the height of the wall from just under 8 feet to just over 5½ feet).

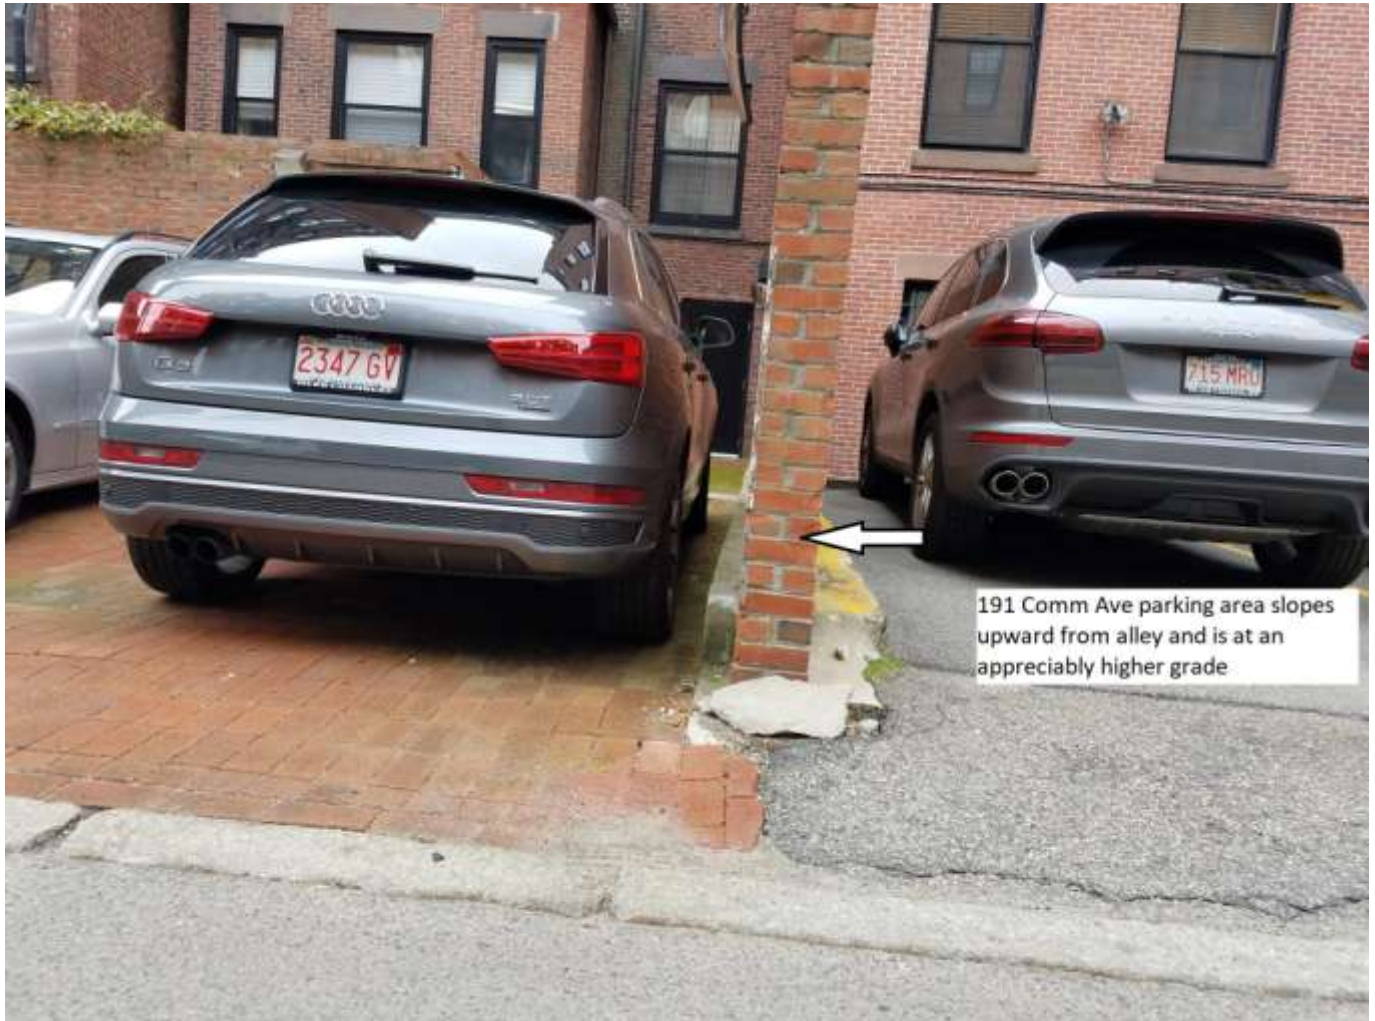
THE FOOTER SERVES A STRUCTURAL PURPOSE AND SHOULD NOT BE TAMPERED WITH

The footer runs the length of parking area. It is part of the foundation between the 2 buildings.

The footer ties into a retaining wall in the 191 parking area and to the corner of their building (see photo on page 13).

The footer is necessary due to 191 Comm Ave parking area being meaningfully (almost a foot) higher than that of 183 Comm Ave, as can be seen in the photograph below.

This photograph is taken while standing in Public Alley 425. On the left is the 183 Comm Ave parking, on the right is 191 Comm Ave.

The mason believes that footer extends below the frost line (and the frost is considered to be 4 feet below the ground).

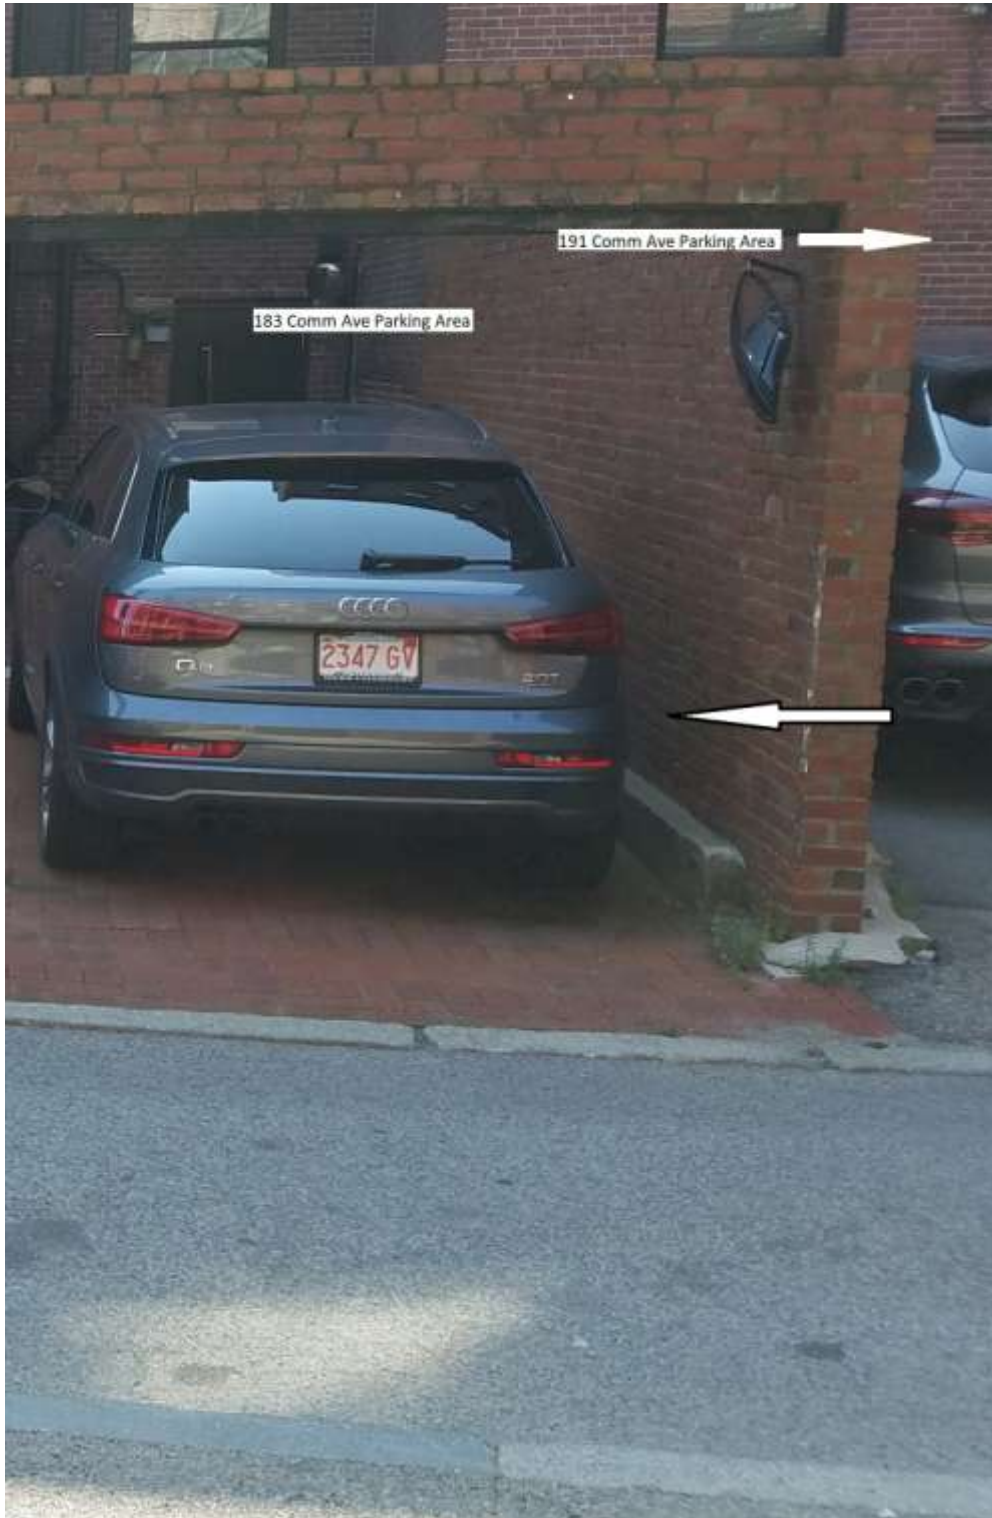
ANOTHER VIEW OF THE HEIGHT DIFFERENCE

The car parked in 191 Comm Ave parking area is appreciably higher than the car in 183 Comm Ave parking area because of the different height in the grade of the two parking areas.

The weight of cars, SUVs and trucks that park in the area add stress and pressure. The footer is a critical component in compensating for the height differential, especially when there is a heavy vehicle parked.

Photo taken from the alley looking at the 183 and 191 Comm parking areas.

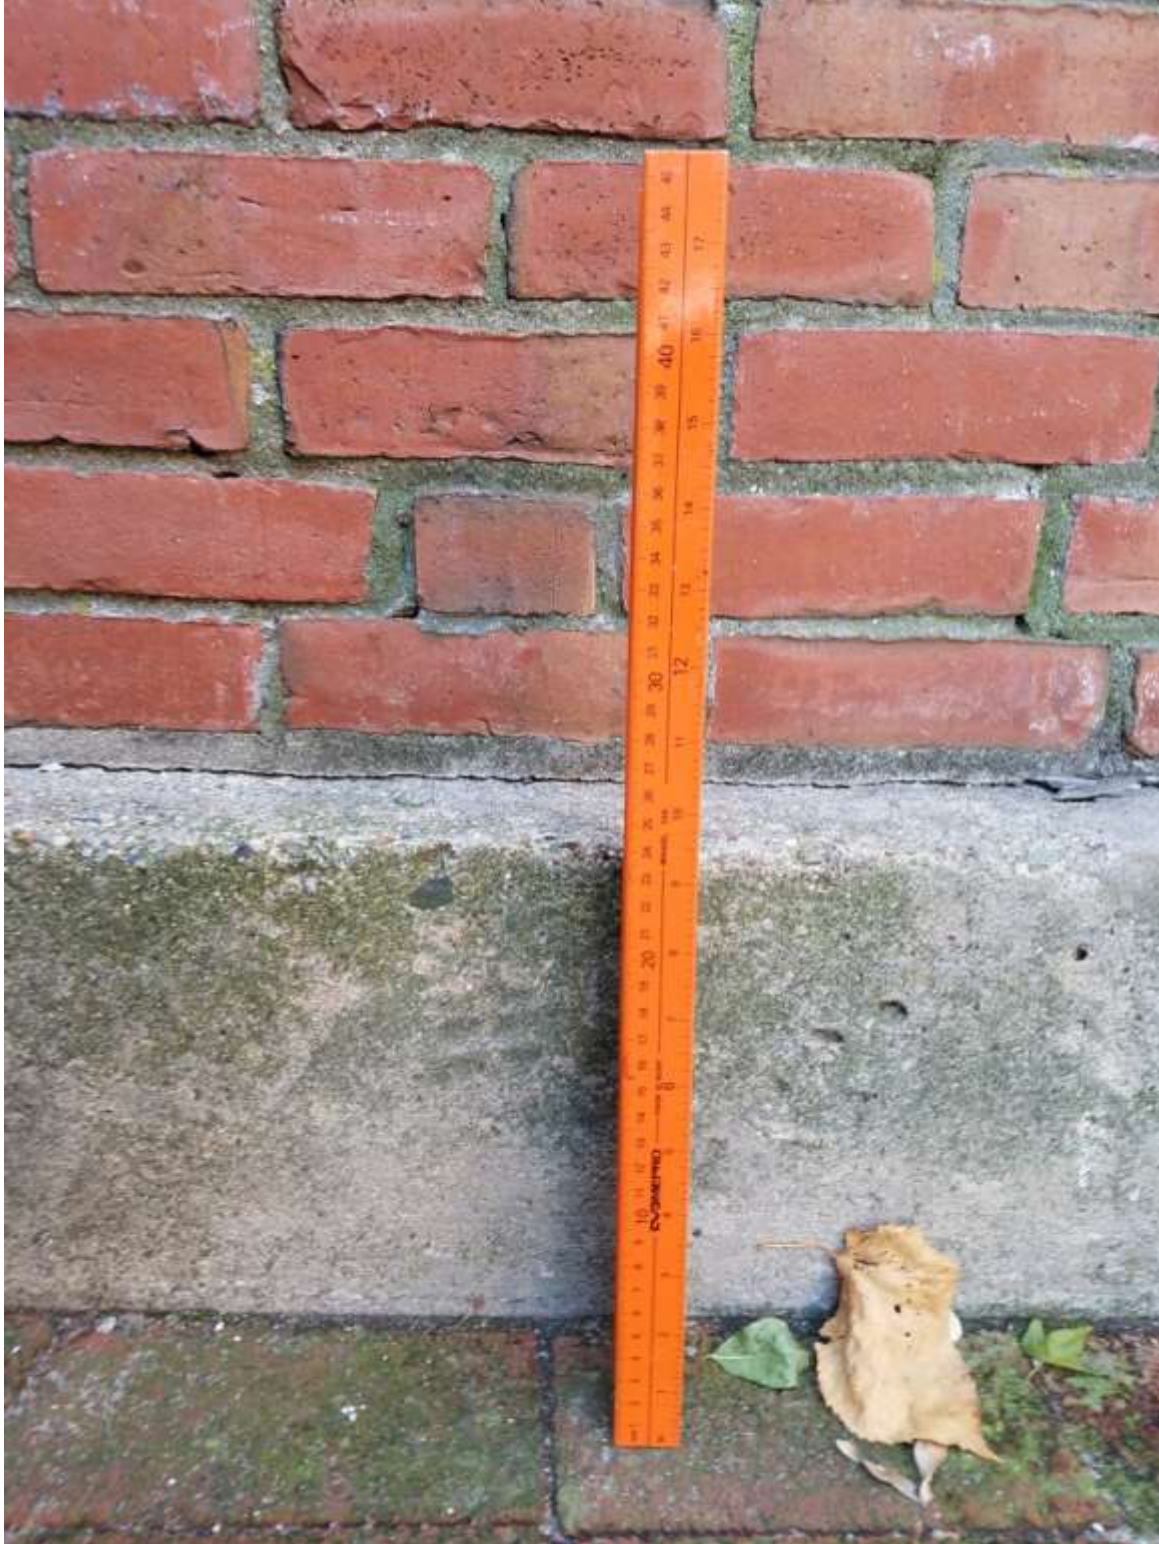
THE FOOTER IS CLOSE TO A FOOT HIGHER THAN THE PARKING LEVEL ON THE 183 SIDE

The footer ranges in height from front to back but is more than 9 inches taller than 183 parking area.

Note that the 183 parking area is relatively level (flat). The 191 parking area has an upward slope (shown later).

This photograph is taken while standing in the 183 Comm Ave parking area facing the brick wall that separates the 183 and 191 parking areas.

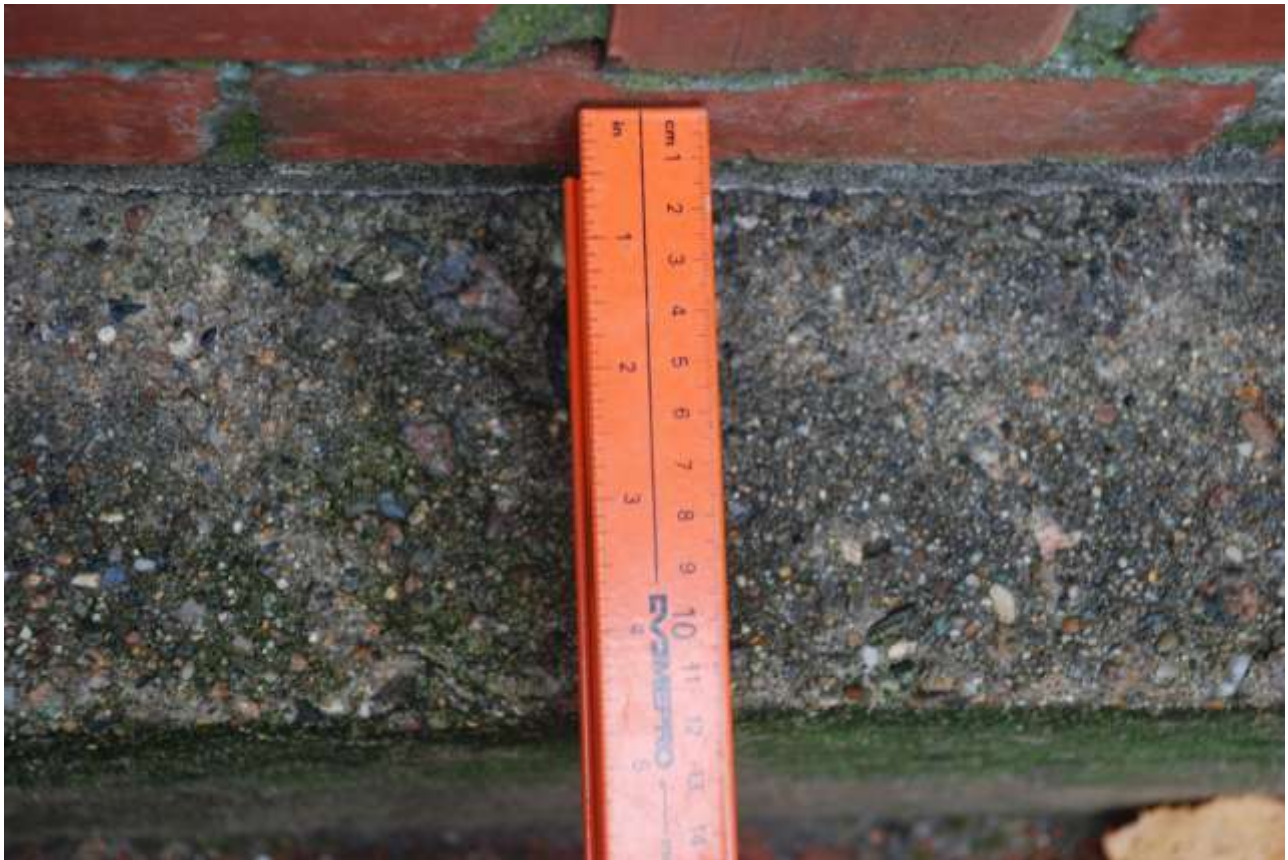
THE FOOTER IS WIDER THAN THE BRICK WALL

The footer extends 4.75 inches beyond the brick wall.

The footer acts like a curb and serves as a "guard rail".

This thick, concrete curb is almost a foot tall so it determines the side of the parking space, not the brick wall.

If a car is parked 2 bricks from the curb in space #3, that leaves a distance of some 14 inches between the car and the wall.

This photo was taken standing in the 183 Comm Ave parking area to measure the setback of the brick wall from the foundation curb.

NB: The size of space #3 is determined by the concrete curb almost a foot tall that sticks out into the parking space by almost 5 inches, not by the brick wall.

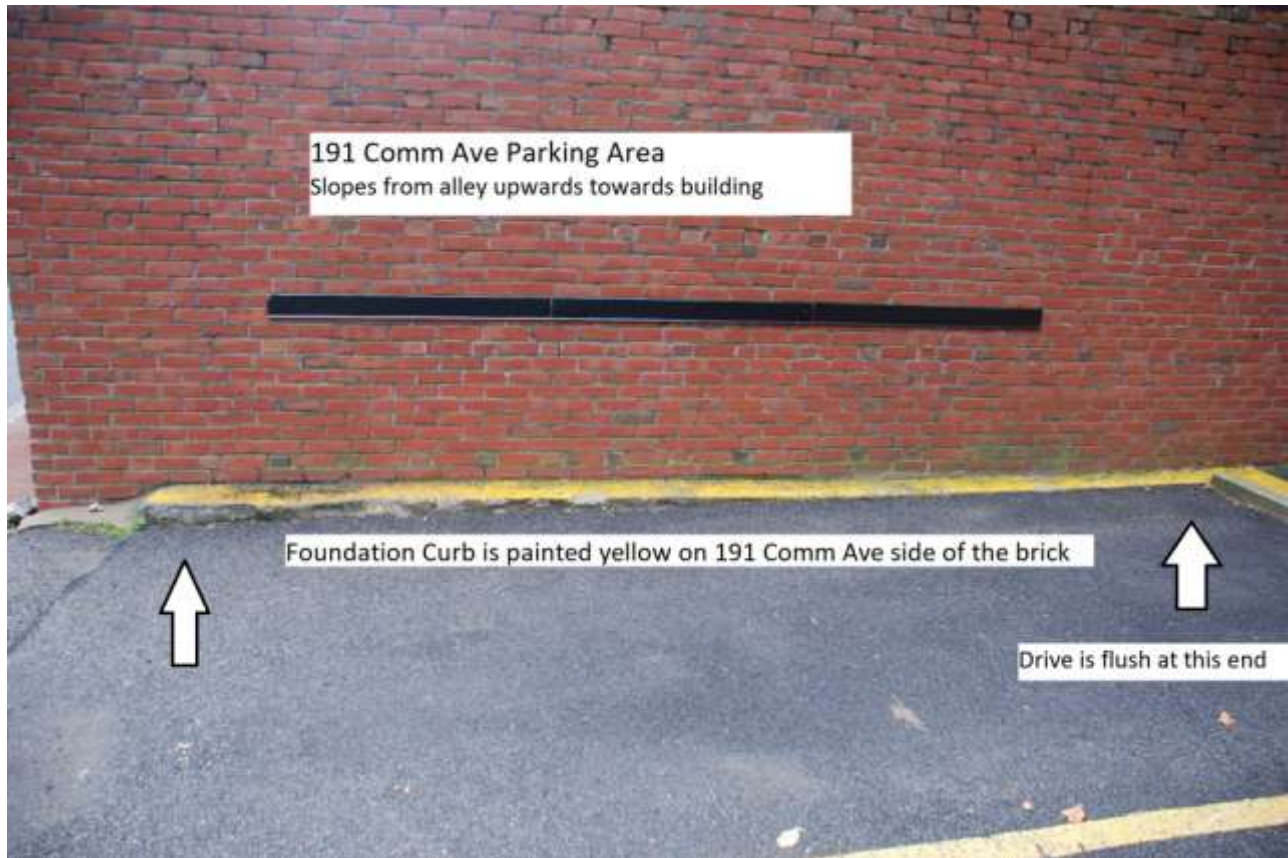
191 PARKING AREA IS NOT LEVEL - IT SLOPES DOWNWARD TOWARDS THE ALLEY

The parking area for 191 Comm Avenue is not level.

It is at a meaningfully higher grade than 183 Comm (ranging from 0 at the alley to 10 inches at the right hand side of the parking space in the photo below).

The parking area has an upward slope (pictured left the alley upwards to the right towards the building). The slope rises more than 10 inches over 24 feet.

This photograph was taken standing in the 191 parking area looking east towards the 183 parking area.

The footer can be seen painted yellow and serves as a retaining wall and is part of the foundation.

Note in the photo at right that the footer ties into a retaining wall that separates the basement of 191 from the parking area. The next page provides a photo of the retraining wall and where the footer connects with 191.

The mason believes that both the weight and the strength of brick wall reinforces and assists in the effectiveness of the foundation retaining wall that holds back the higher grade of the 191 parking area both from the 183 parking area and the retaining wall at the rear of 191 Comm parking area.

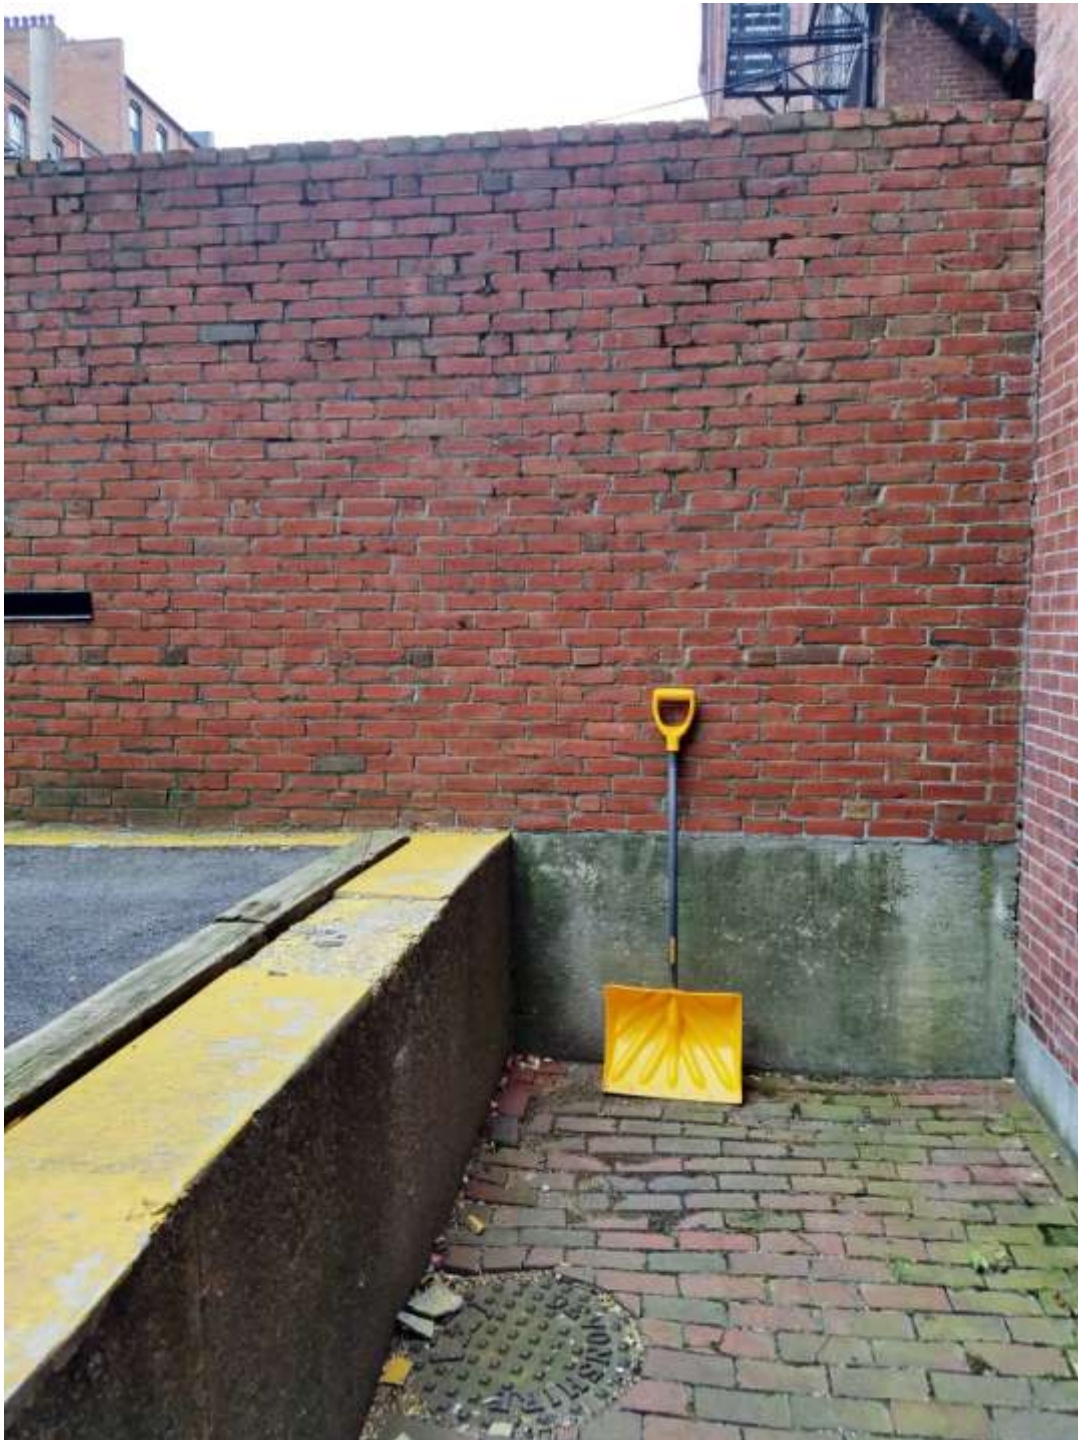
THE FOOTER IS A STRUCTURAL COMPONENT

The picture below supports the mason's instincts that the footer extends below the frost line. The snow shovel stands 54 inches tall.

The footer also appears to tie in to the retaining wall that is a part of the 191 parking area and the corner of 191 Comm Ave.

Without the original foundation drawings, it is difficult to know how these structural elements interact.

Picture is taking behind 191 Comm Ave facing the wall that blocks the 183 Comm parking area
