103 WARREN AVENUE SITE LOCATION & SITE PLAN

103 WARREN AVENUE DESCRIPTION OF PROPOSED WORK

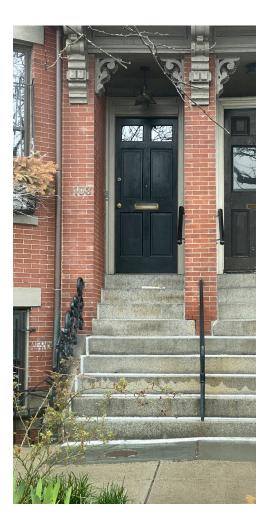
EXISTING FRONT ENTRY DOOR TO BE RESTORED & REPAINTED W/ NEW GOLD LEAF STREET NUMBER

EXISTING GLASS INFILL TO BE CLEANED,
