127 COMMONWEALTH AVENUE

BACK BAY — BOSTON

EXISTING AND PROPOSED COMMONWEALTH AVENUE ELEVATIONS

127 Commonwealth Avenue
Back Bay – Boston – Massachusetts

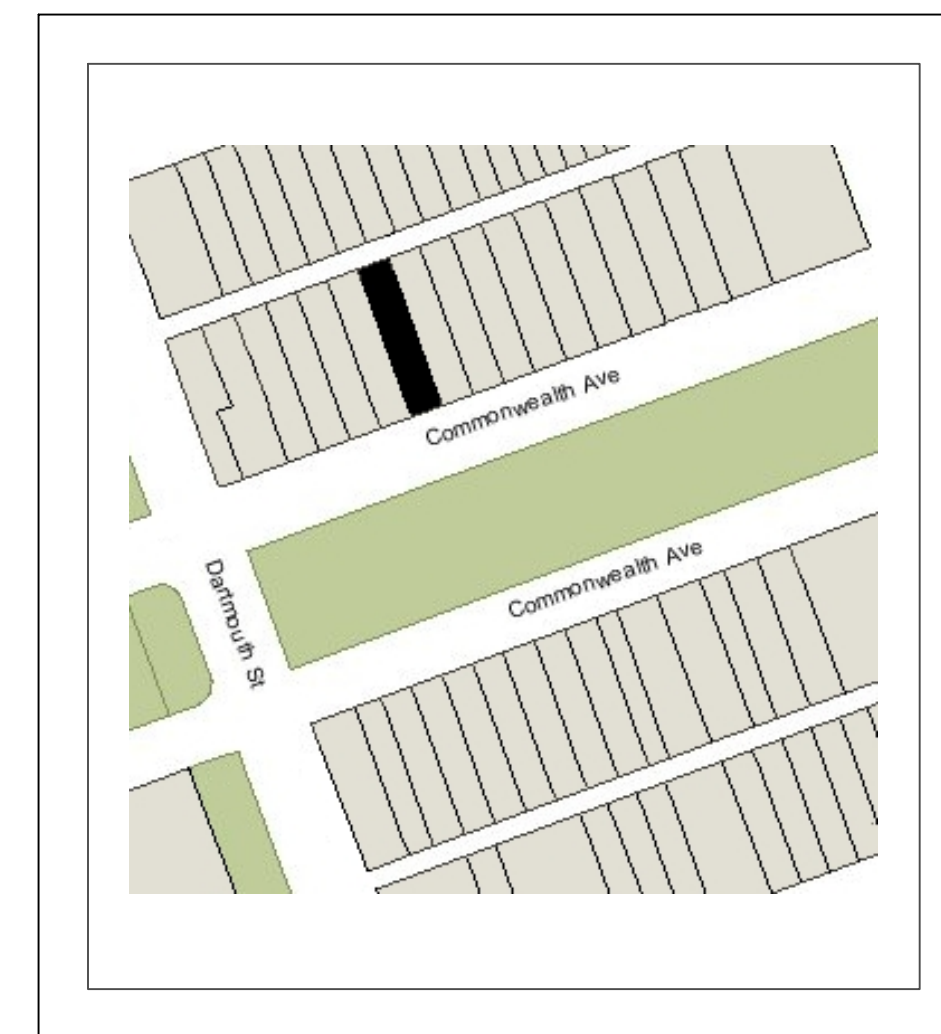
127 COMM AVE EXISTING GROSS SQUARE FOOTAGE	
<u>EXISTING</u>	
GROUND	1,688 G.S.F.
FIRST	1,643 G.S.F.
SECOND	1,607 G.S.F.
THIRD	1,607 G.S.F.
FOURTH	1,603 G.S.F.
<hr/>	
TOTAL:	8,148 G.S.F.

127 COMM AVE PROPOSED GROSS SQUARE FOOTAGE	
<u>PROPOSED</u>	
GROUND	1,688 G.S.F.
FIRST	1,643 G.S.F.
SECOND	1,607 G.S.F.
THIRD	1,607 G.S.F.
FOURTH	1,603 G.S.F.
(N) PENTHOUSE	663 G.S.F.
<hr/>	
TOTAL:	8,811 G.S.F.

FLOOR AREA RATIO (F.A.R.): 3.0
 EXISTING LOT SIZE: 3,237 SF (PER CITY OF BOSTON ASSESSING DEPARTMENT) 3,237 SF X 3 = 9,711 G.S.F.

PROPOSED GROSS SQUARE FOOTAGE IS 900 G.S.F. UNDER F.A.R.
