1. Proposed painted metal ladder to existing raised first floor fire escape landing. Color to match existing fire escape.
2. Proposed solid stained wood louver fence and painted metal frame with door to secure fire escape ladder.
3. Trench parking area asphalt for installation of new sprinkler service. replace to match existing.
4. Re-paint existing fence

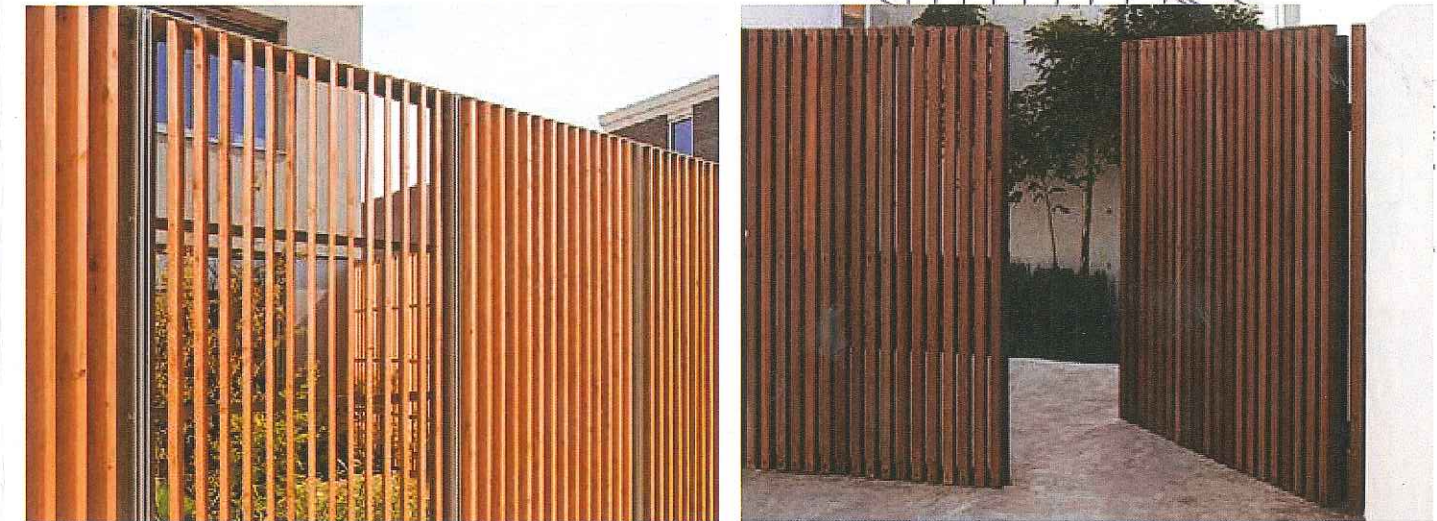
Proposed fence precedents and 3d model

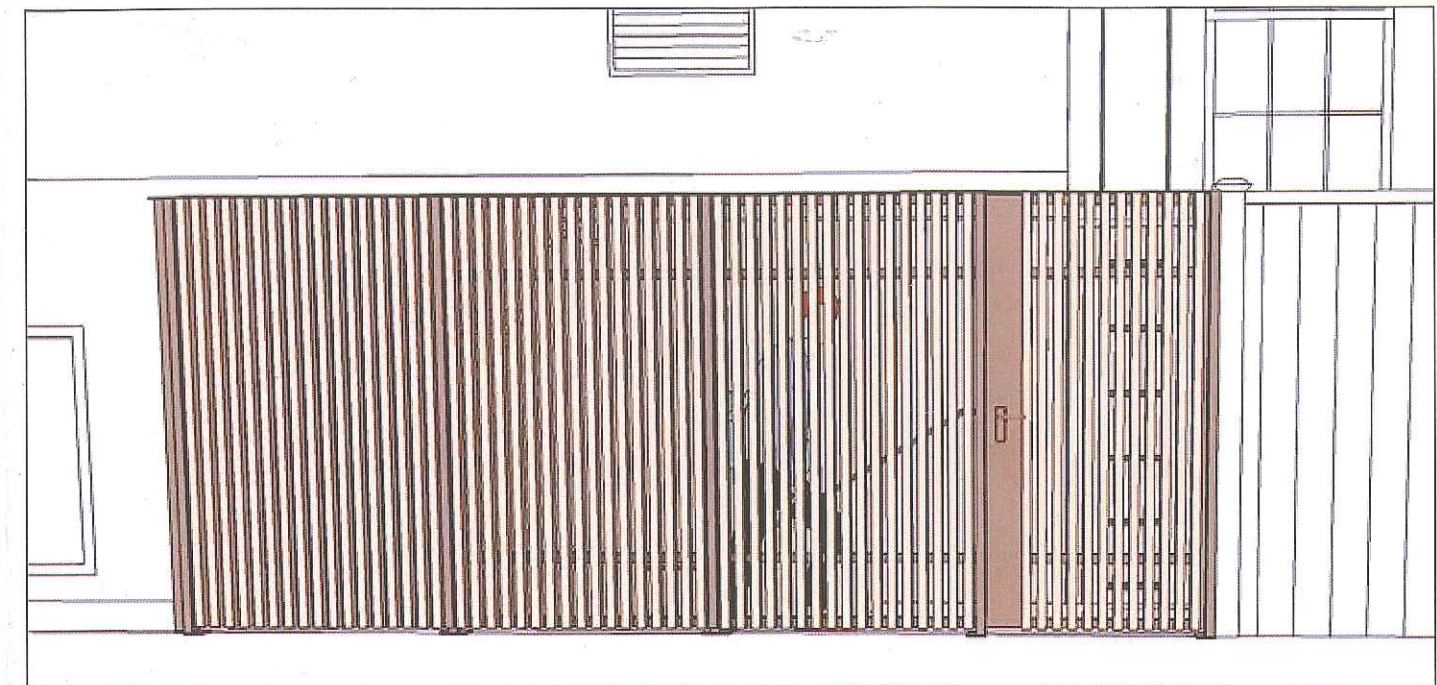
Enlarged view

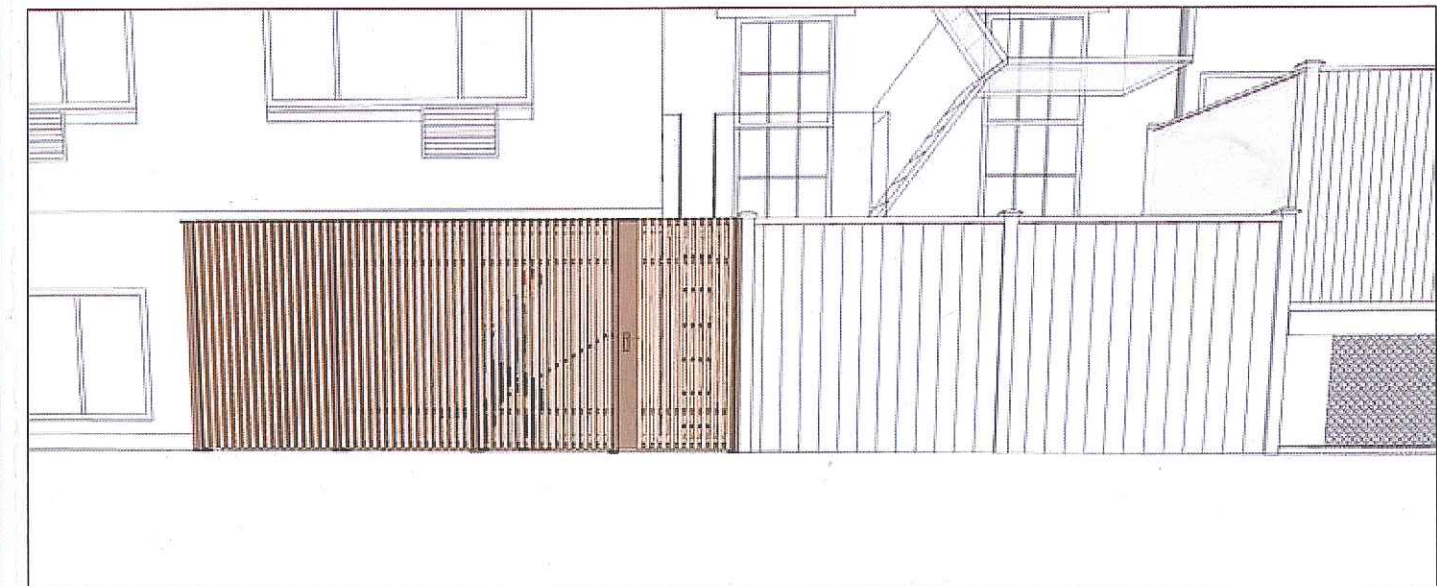
Proposed fence and door
