# 64 W RUTLAND SQ

BOSTON, MA 02118

**SELDC**

2/25/2020

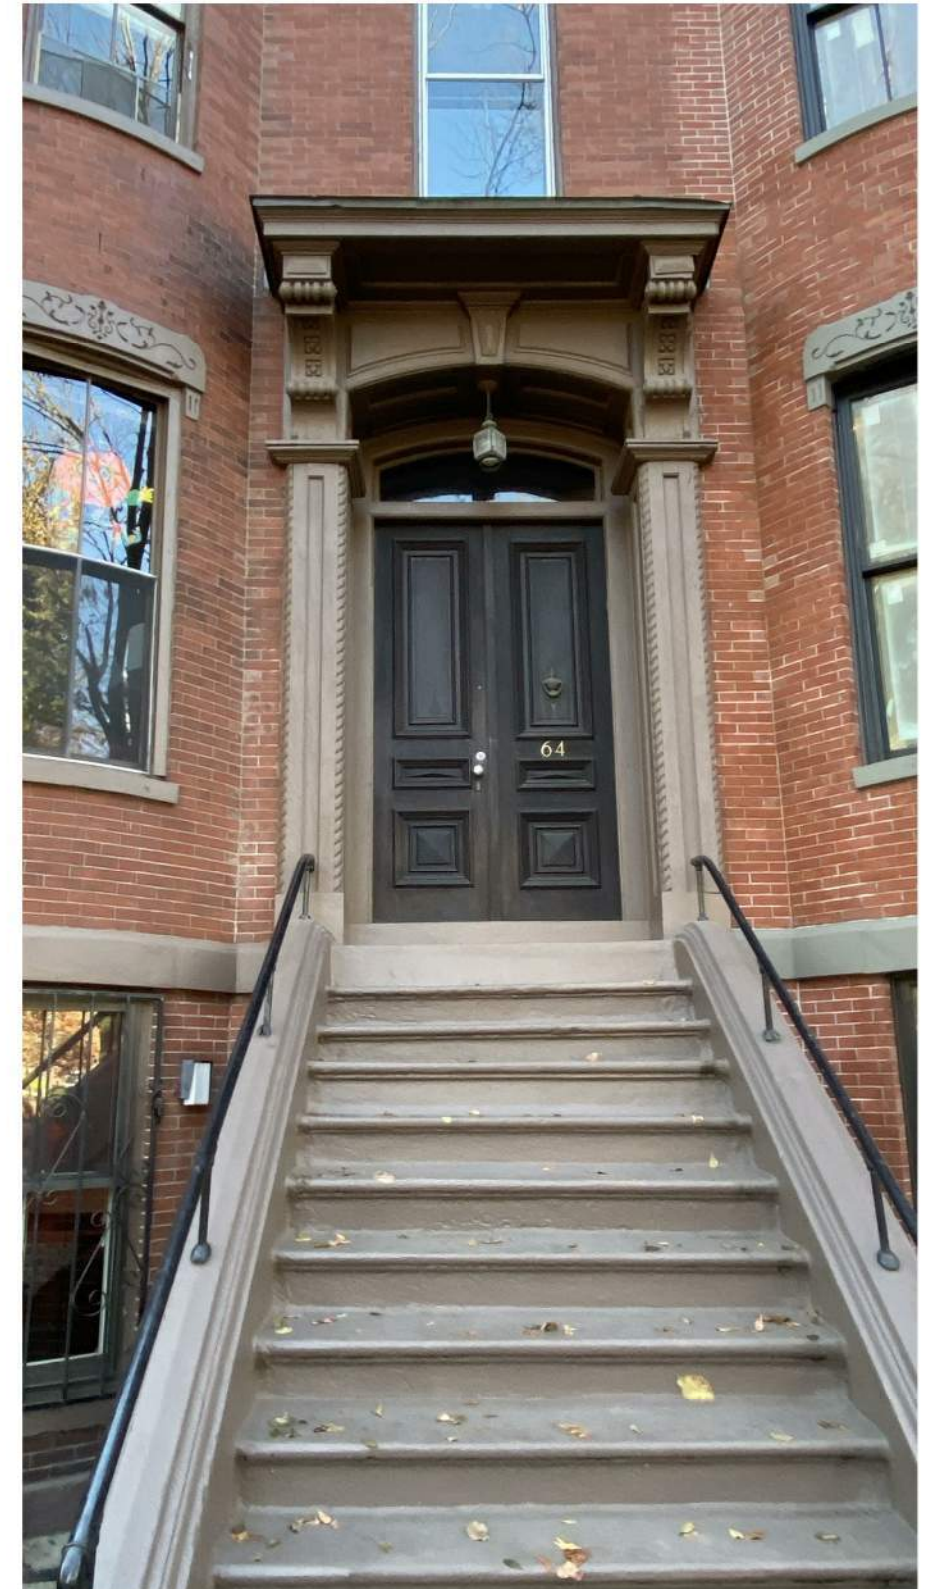
1 RUTLAND SQUARE ELEVATION - PROPOSED  
1/8" = 1'-0"

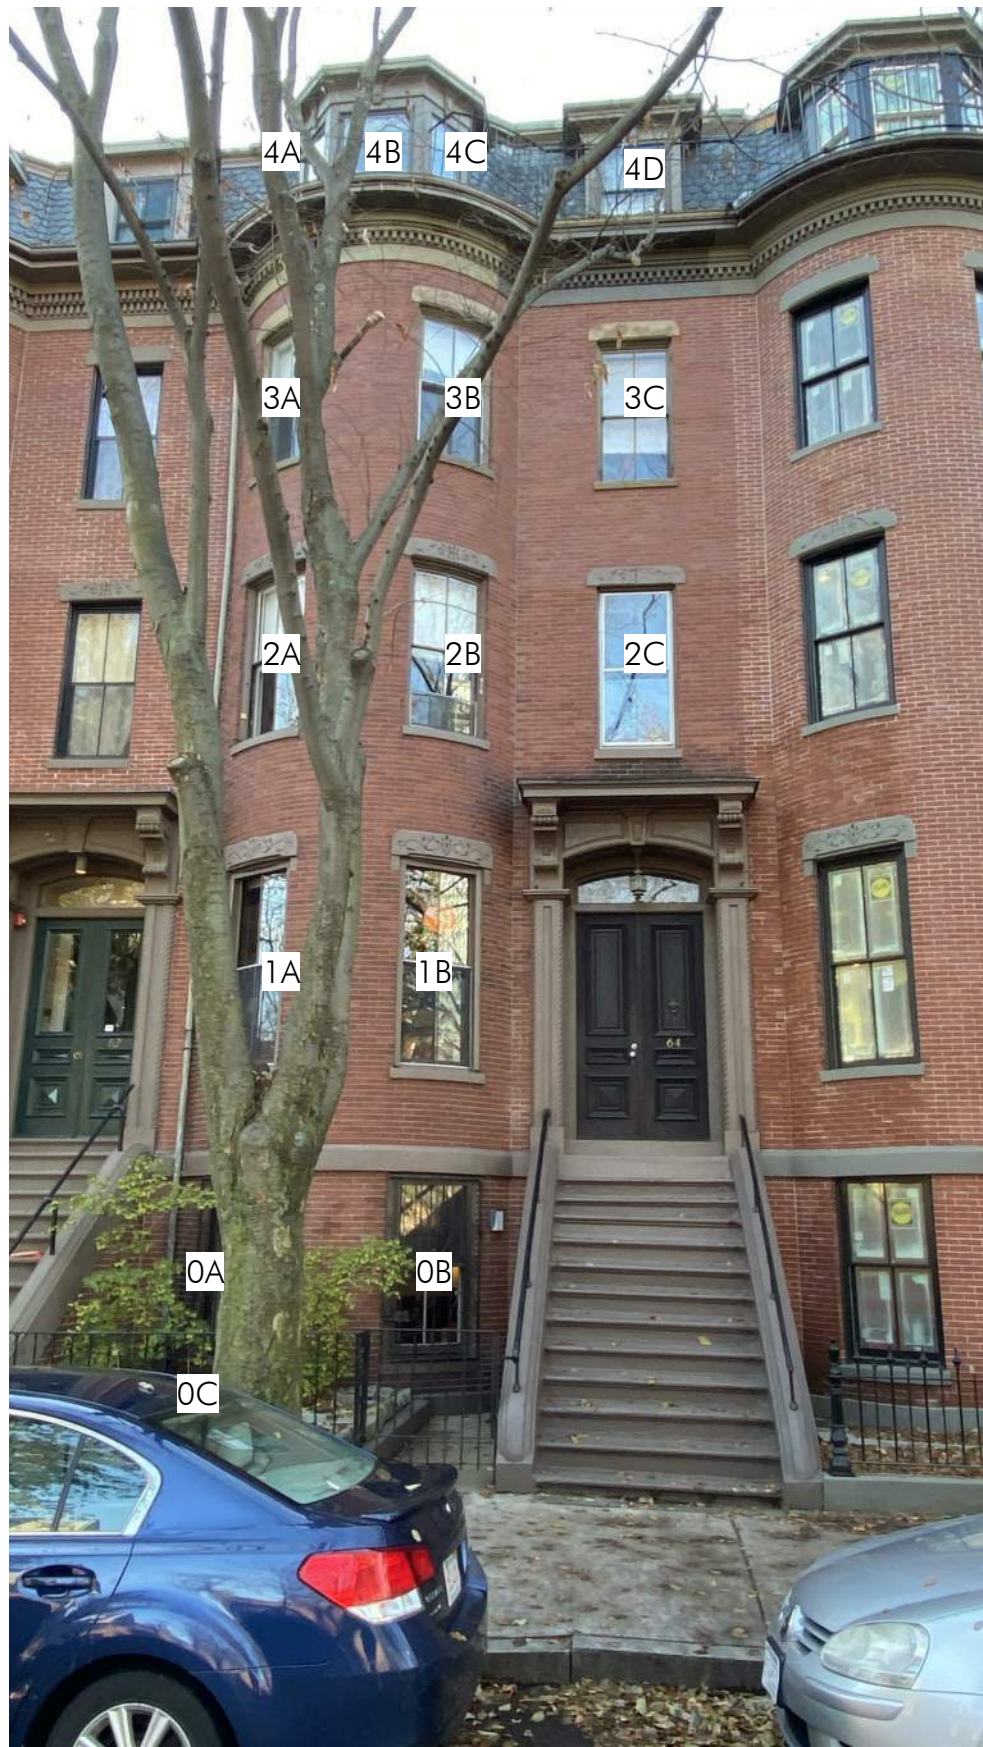
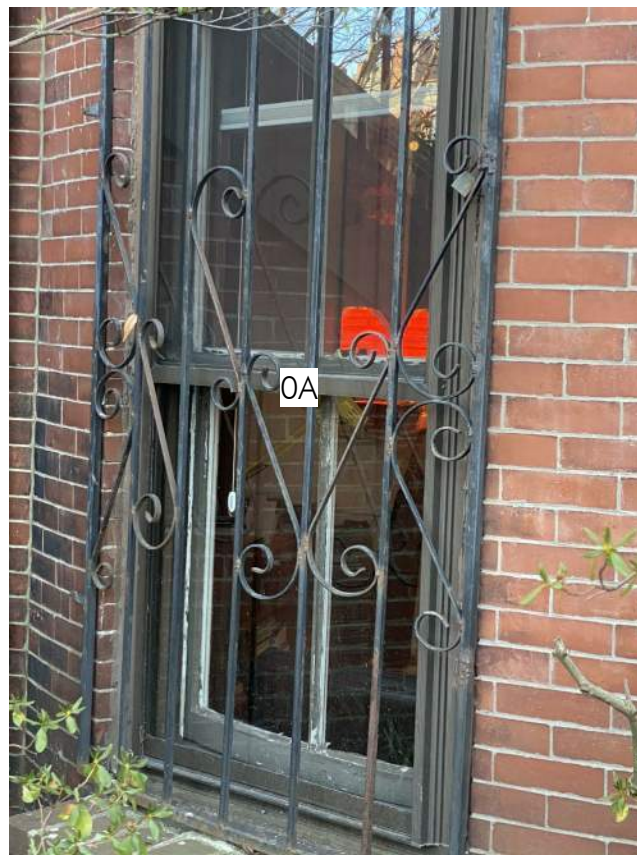
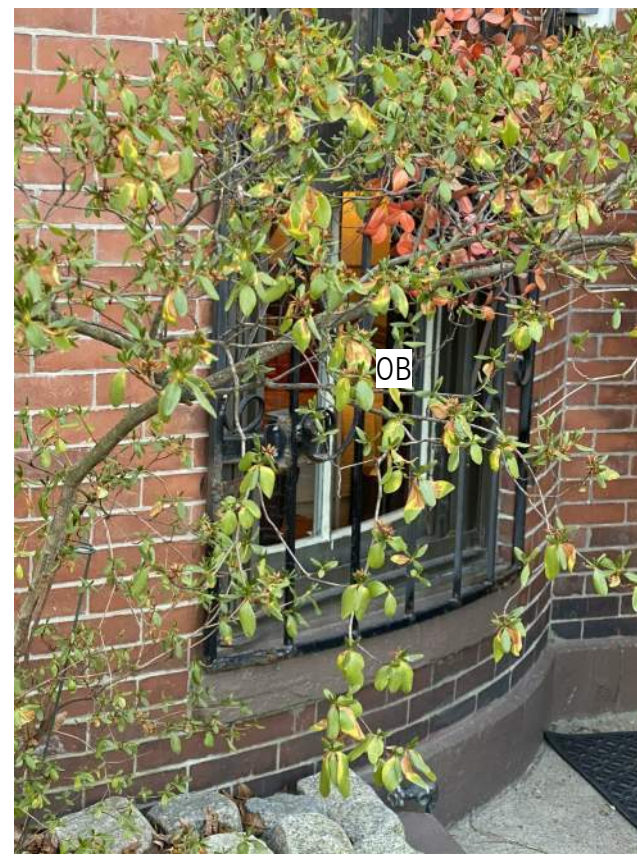
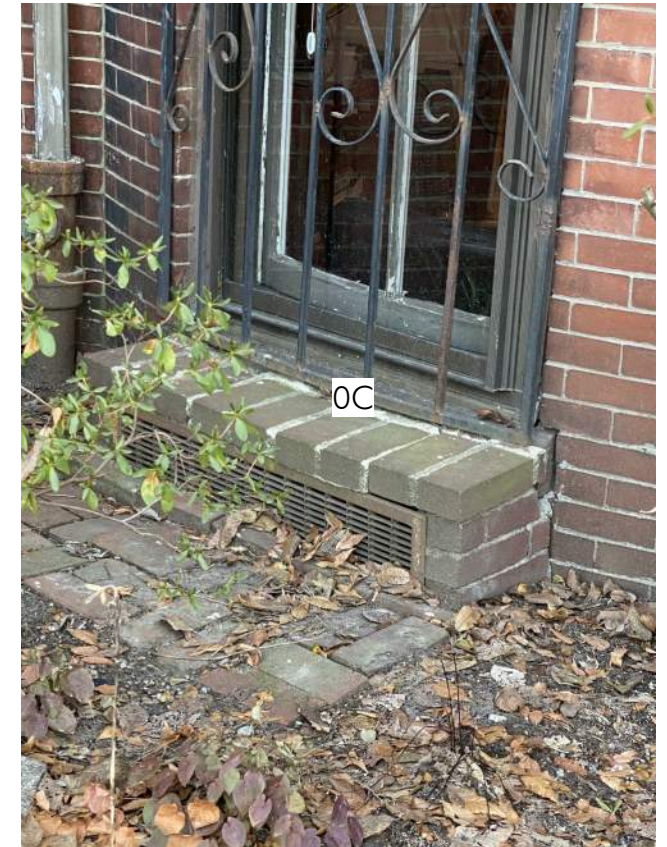
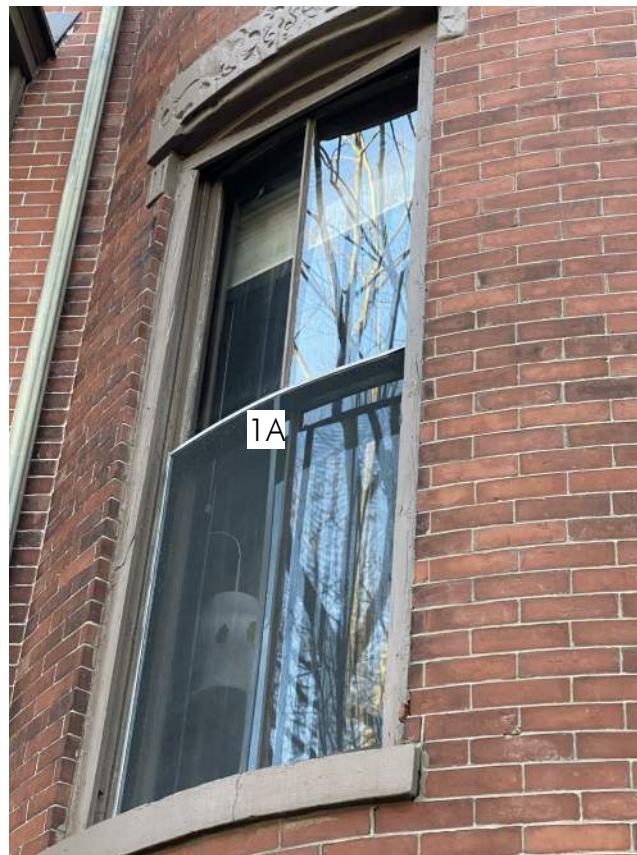
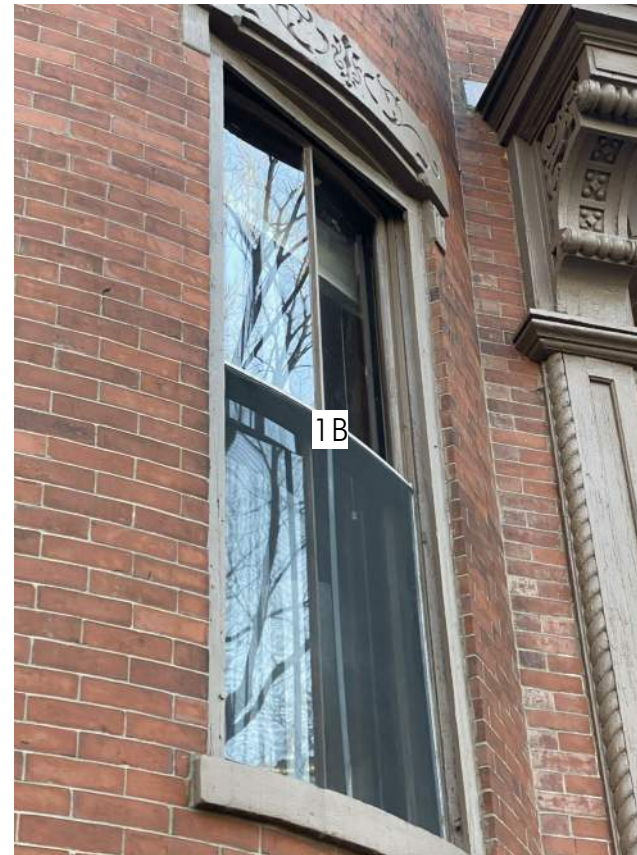
TOTAL OF (7) WINDOWS BELIEVED TO BE ORIGINAL:  
 WINDOWS 0A, 0B (GARDEN LEVEL)  
 WINDOWS 1A, 1B (PARLOR LEVEL)  
 WINDOWS 2A, 2B, 2C (SECOND FLOOR)

EXISTING WINDOW WELL TO BE RE-OPENED.  
 NEW WOOD WINDOW PROPOSED

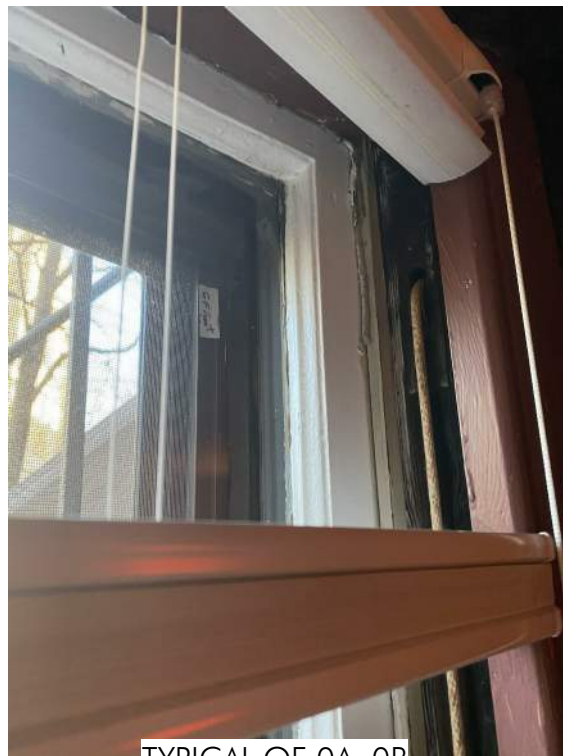
0A

TYPICAL OF 0A, 0B

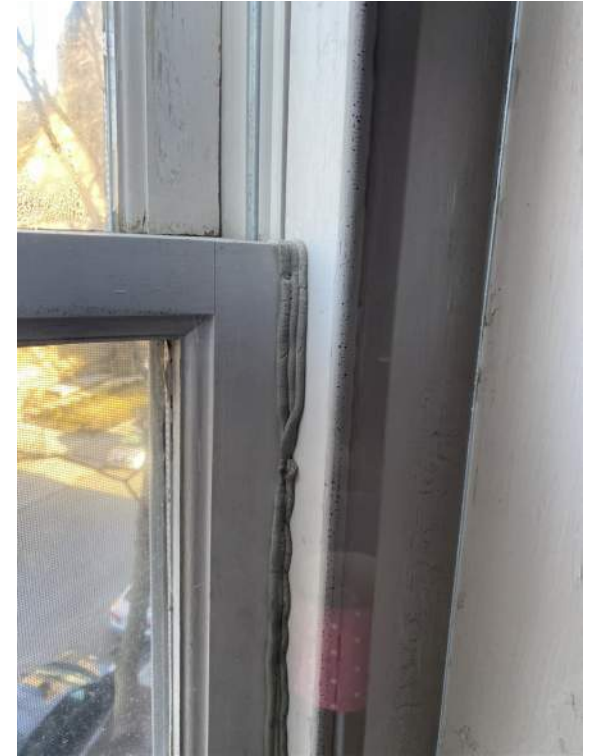
TYPICAL THIRD FLOOR WINDOW DETAILS
