PROPOSED LOADING DOCK RENOVATION / FREIGHT ELEVATOR

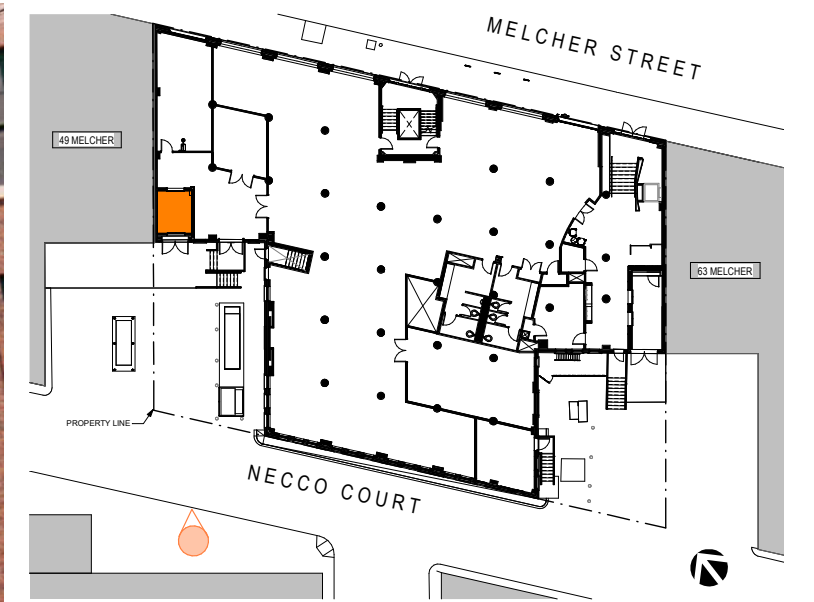
NEW SHAFT WALL BEHIND WINDOWS TO BE PAINTED WHITE

EXISTING WINDOWS TO REMAIN

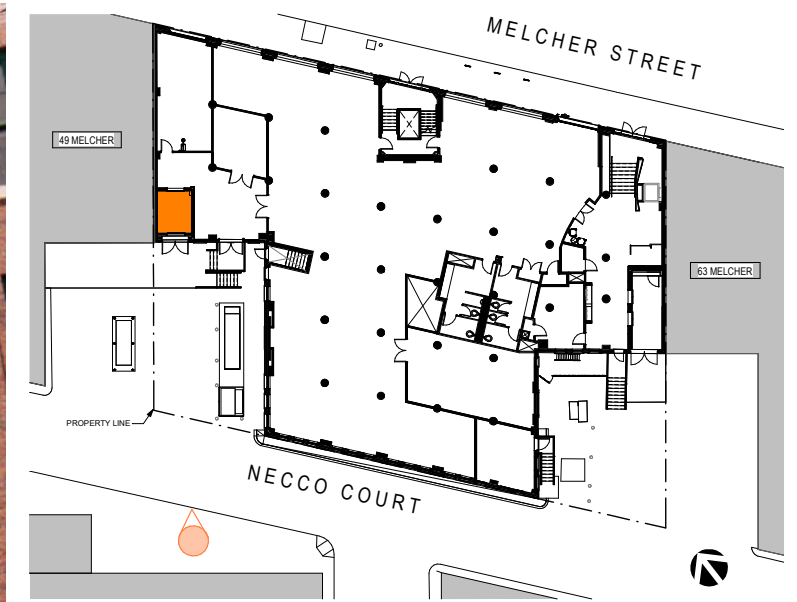
NEW SHAFT WALL BEHIND WINDOWS TO BE PAINTED BLACK

EXISTING WINDOWS TO REMAIN
