82 Waltham Street – front door replacement

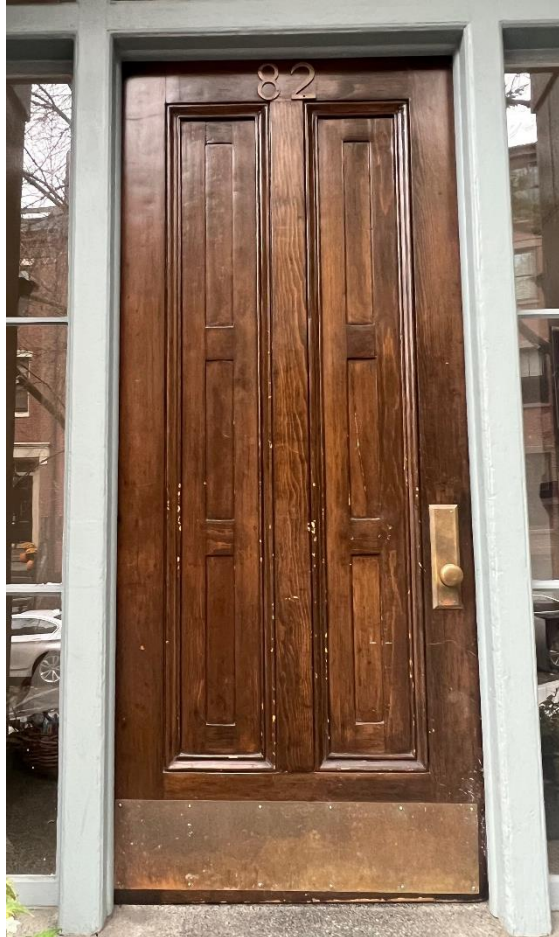
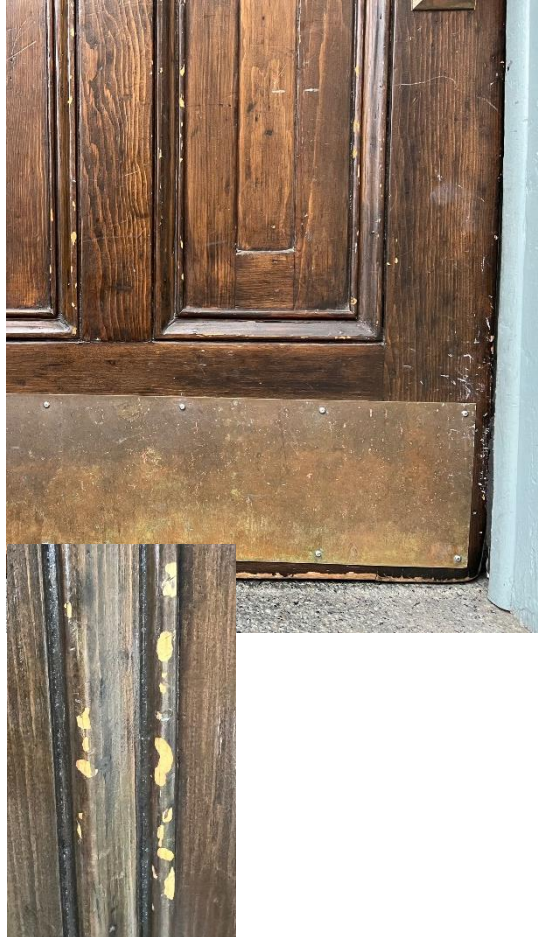
Existing conditions – pine wood door

- Current door is made of stained **softwood** (probably pine wood), which is not standard for the South End
 - Front doors are typically made of hardwood – mahogany or oak
 - Door is most likely a **non-historically correct replacement**
- Given its soft material, the door has been **prone to damage** and has required frequent renovations

- Replace this softwood door with a mahogany door, painted in black
- Custom made by Olde Bostonian to replicate a historic design found on other buildings in the South End
 - See next page

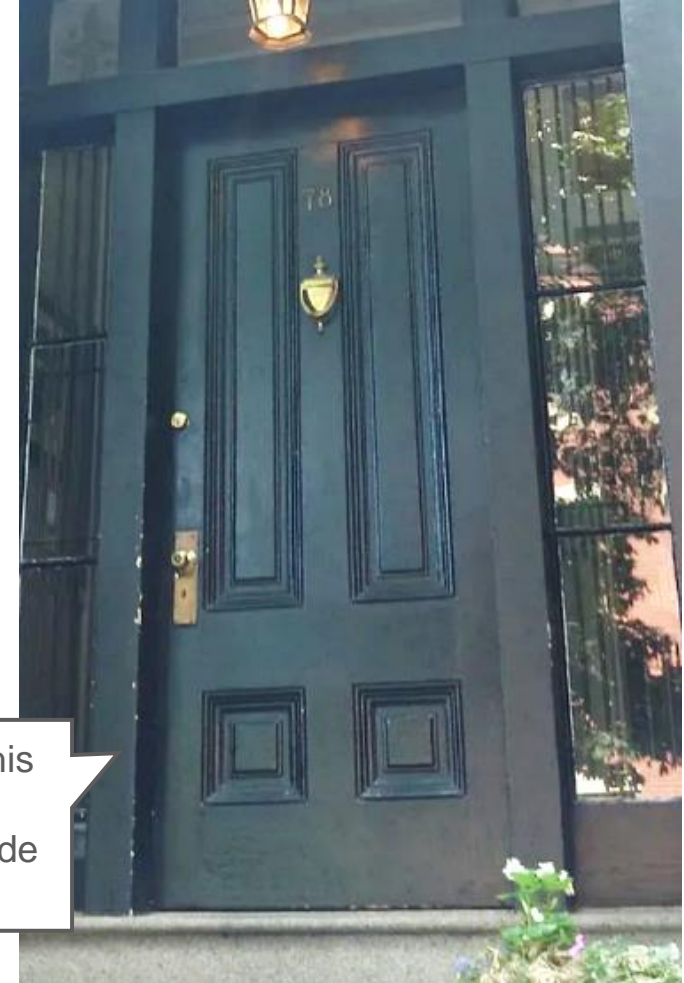
Proposed replacement – mahogany door

Custom replica of this historic South End design, made by Olde Bostonian
