The Calf Pasture Pumping Station

Boston Landmarks Commission

Study Report

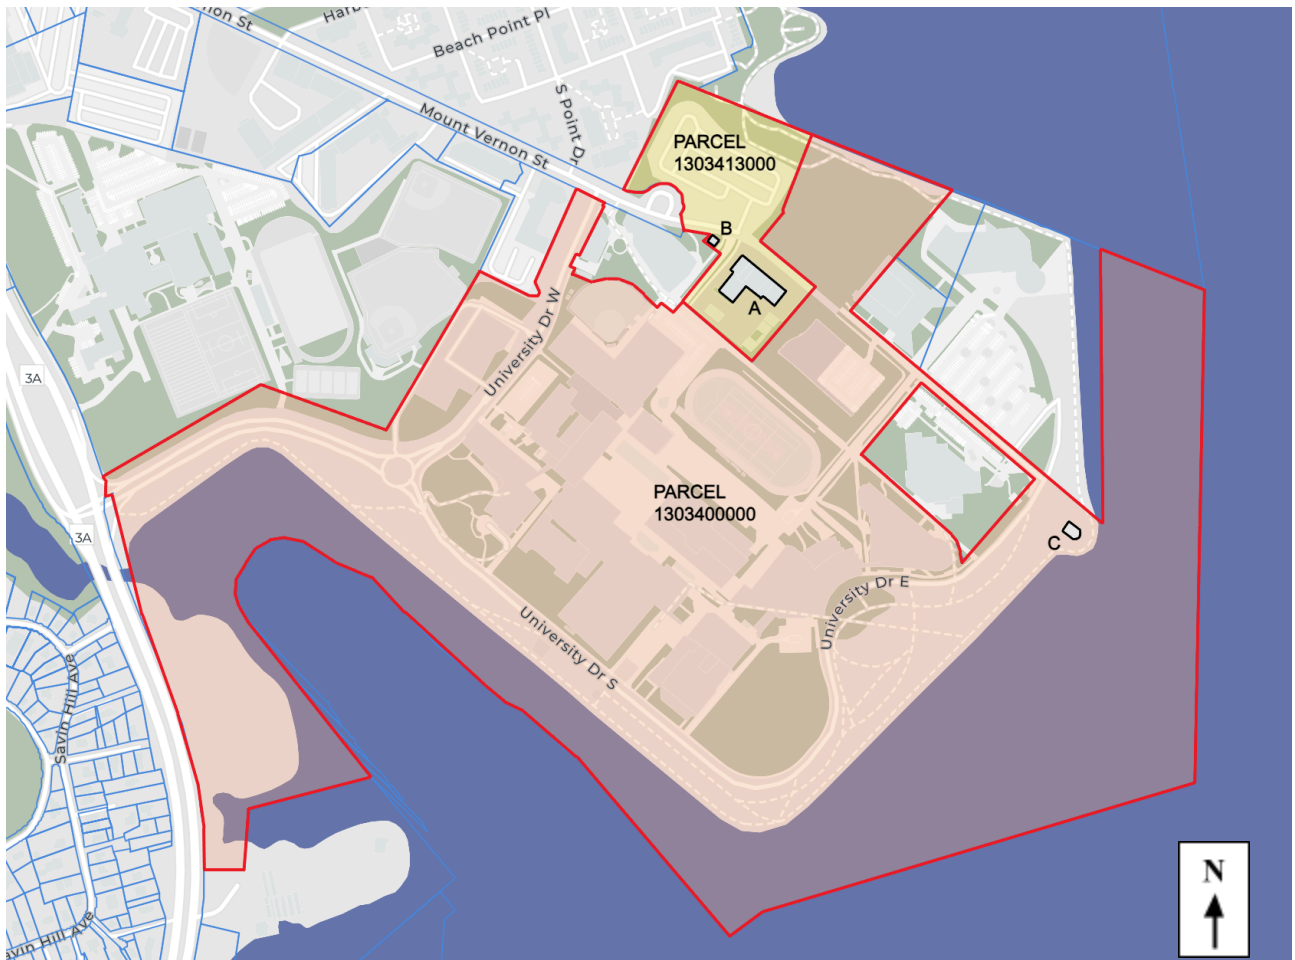
Figure 1A. Map showing the location and boundaries of parcels 1303413000 and 1303400000. A = Pumping Station, B = Gate House/Filth Hoist, C = West Shaft Entrance.

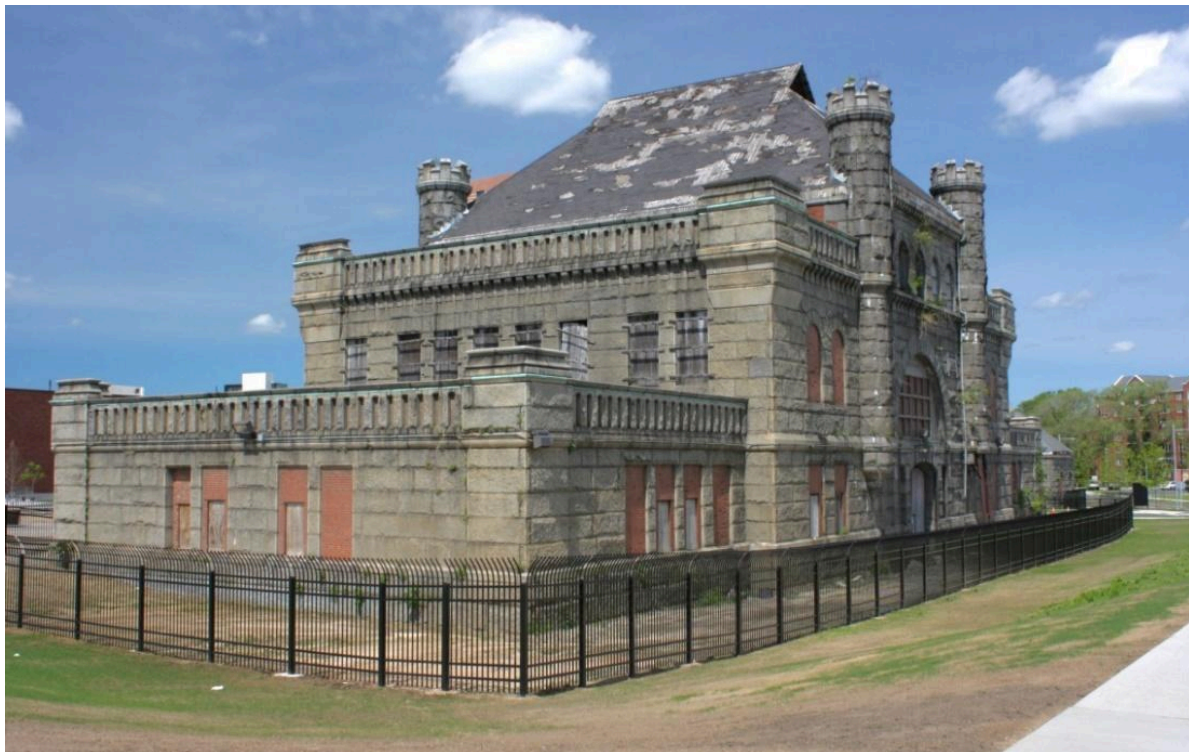
Figure 2. Pumping Station: Engine House.

The Mount Vernon Street (University Drive North) façade (northeast elevation, **Figure 2**) contains a large, wide, center doorway with a segmentally arched opening flanked by a round-arched window on each side. At the second level, a monumental, semicircular arched window surmounts the doorway, flanked by decorative stone plaques with channeled frames and bull's-eye corner blocks in the spandrels. The plaque to the left of the entrance is carved with the letters "B.I.S." (Boston Improved Sewer, **Figure 7**); the plaque to the right is inscribed with the year 1883. The third story of the central volume has five round-arched windows; centered on the corner turrets are a thin rectangular window on the third-floor level and a slender round-arched window above. The two-story volumes each display two window bays, with rectangular windows on the ground floor and round-arched windows above. The façades of the one-story wings are similar, but not identical, to each other: the southeastern wing has four off-center rectangular openings, loosely grouped as a triplet and a single opening, while the northwestern wing has three grouped, off-center rectangular openings.

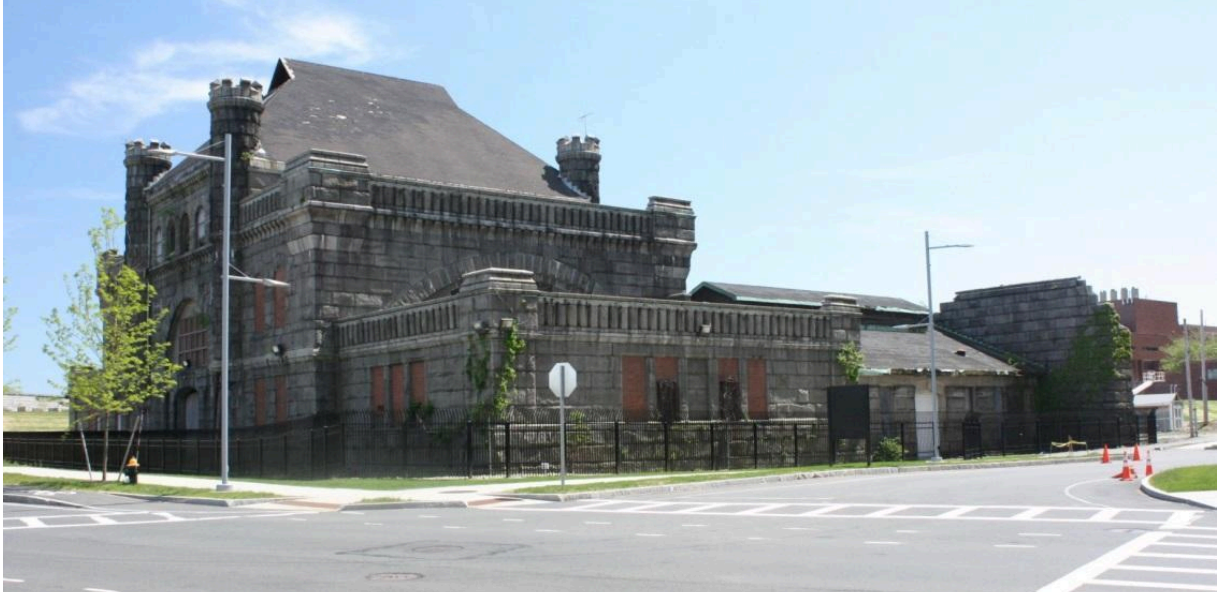
Figure 3. Pumping Station.

The northwest side elevation (facing the Gate House/Filth Hoist; **Figure 3**) displays five grouped rectangular windows centered on the first-floor wing and a broad arched window across most of the second floor. Third-floor windows on the center volume are not clearly visible but contain round-arched openings with granite keystones.

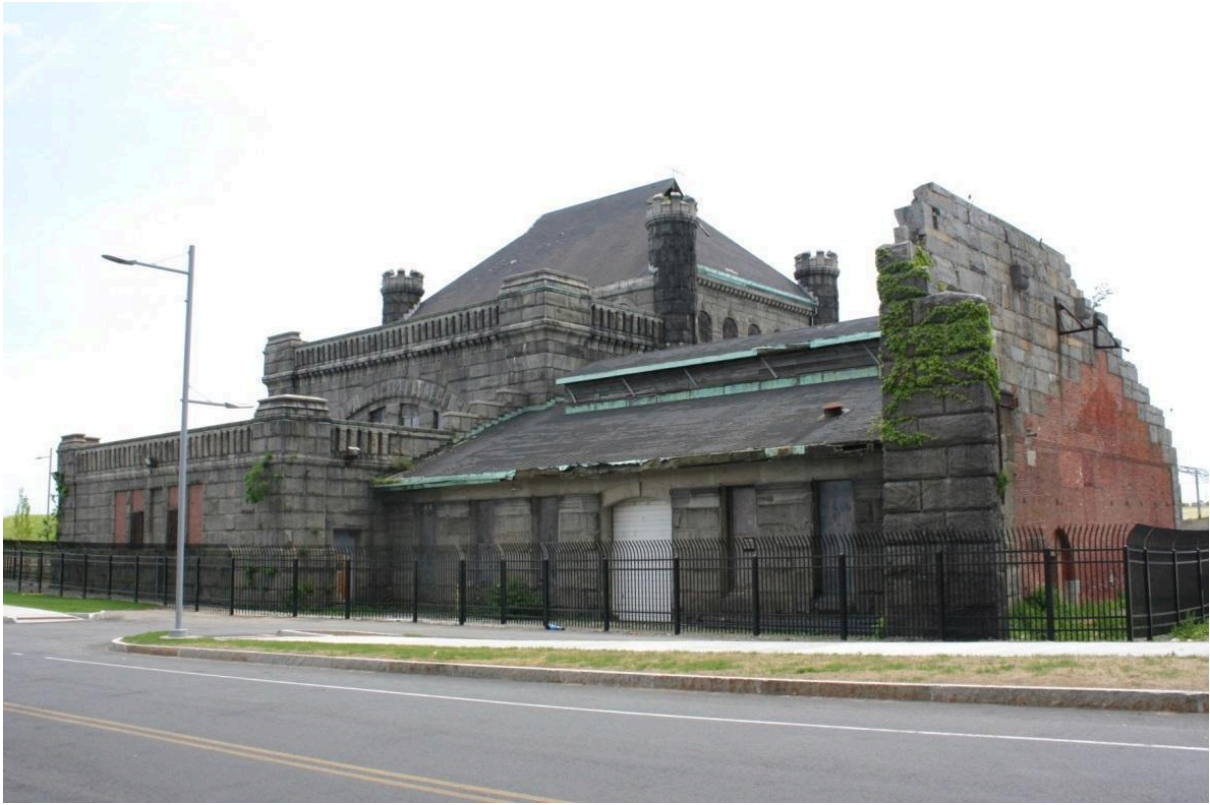
Figure 4. Pumping Station: Engine House and Boiler House.

Oriented northeast/southwest and measuring 80 feet by 60 feet, the Boiler House rises one story to a gabled roof with a modest gabled clerestory (**Figure 4**). The long side elevations each contain a slightly off-center doorway with a segmentally arched lintel ornamented with a keystone and a high, molded, granite entablature. The northwest elevation has three windows on each side of the slightly off-center entrance, while the more asymmetrical southeast elevation has only five window bays. Remnants of copper flashing and gutters remain at the asphalt-clad roof. Although most of the clerestory fenestration is boarded up, a narrow band of small-paned windows is visible on the southeast side. The southwest end of the Boiler House abuts a two-story fragment of granite block wall with stepped brick infill marking the connection with the former coal house. The granite portion of the wall retains a small rectangular doorway, while a small, round-arched recess surrounds another single-leaf doorway in the brick infill wall.

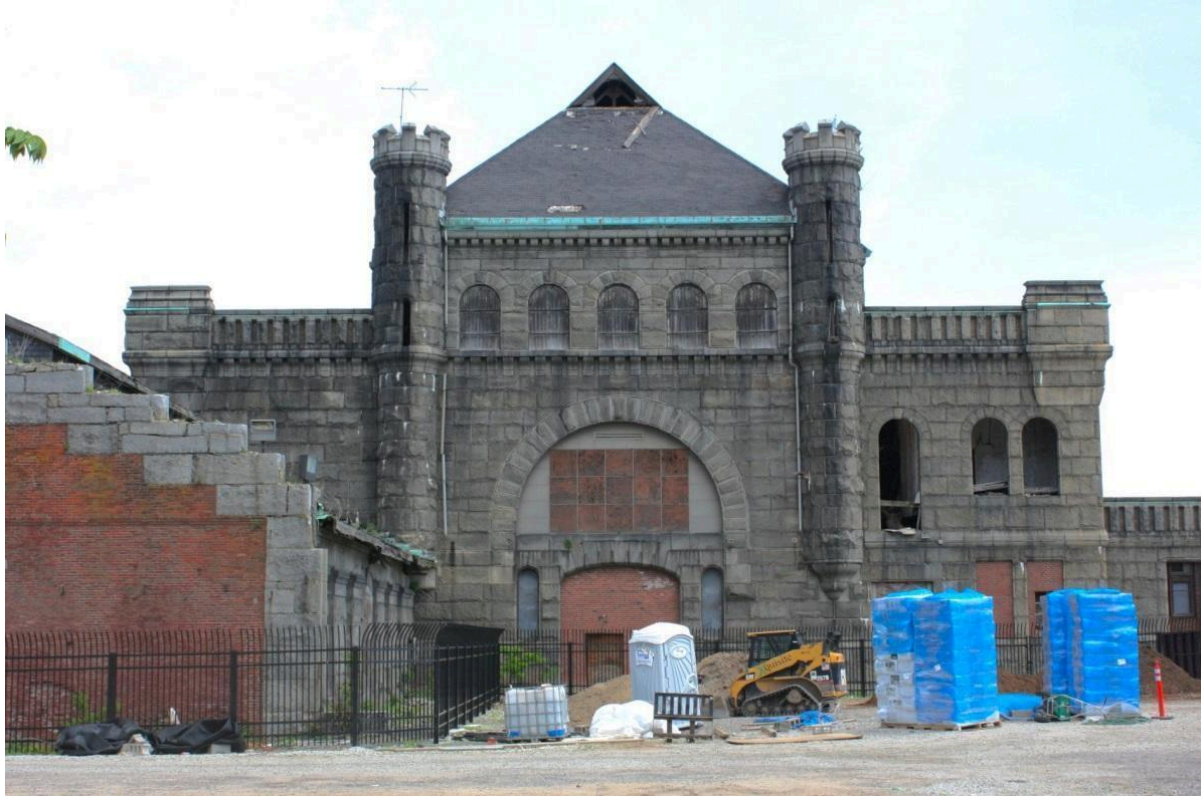
Figure 5. Pumping Station: Boiler House and Engine Room, rear elevation.

The rear (southwest) elevation of the Pumping Station (**Figure 5**) is similar to the façade, with turrets framing the three-story center volume, which also features a large, segmentally arched doorway surmounted by a monumental, semicircular arched window and five bays of round-arched windows at the upper story. Because of the attached Boiler House ell, the northwestern end of the rear elevation is largely blank; a recessed single-leaf door is distinctive in the westernmost bay. The two-story volume on the southeast of the center block has three bays on each floor, including a rectangular door and two windows at the first floor and a round-arched doorway, and two round-arched window openings at the second story. The one-story wing contains four grouped rectangular windows, set off-center.

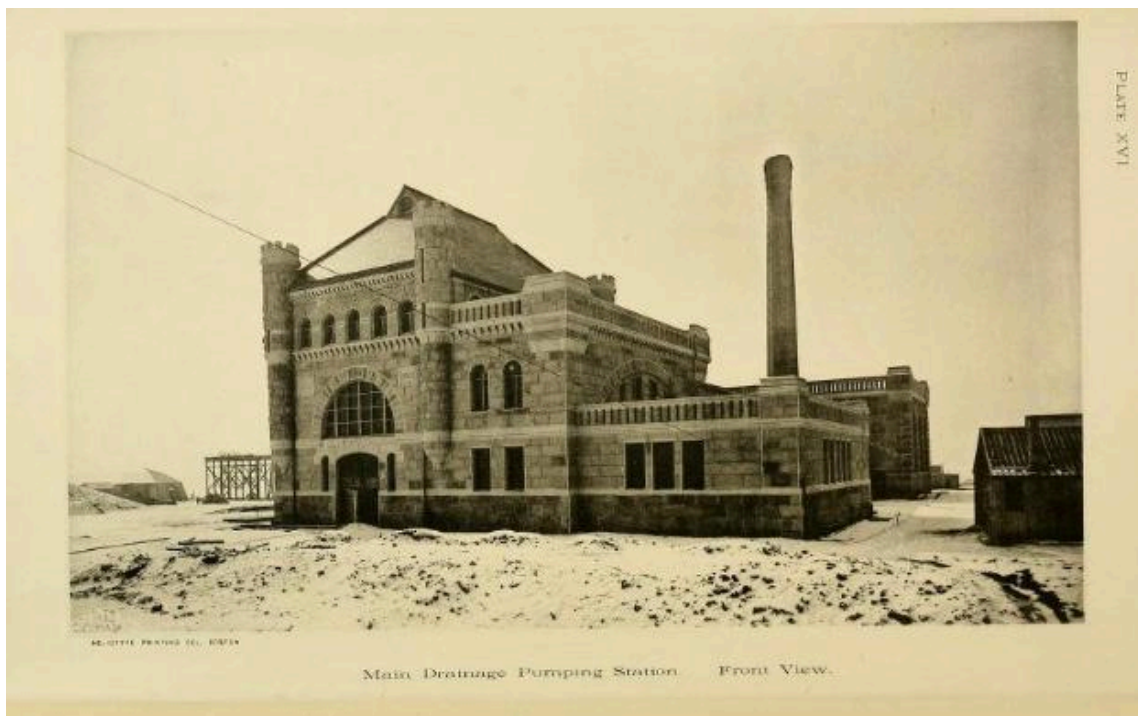
Figure 17. View of the front of the Pumping Station
Source: Clarke, Eliot C. Main Drainage Works of the City of Boston. Boston: Rockwell & Churchill, 1888.

The present Pumping Station, Gate House/Filth Hoist, and West Shaft Entrance buildings were all part of the original construction of the Calf Pasture Pumping Station Complex, designed by City Architect George A. Clough (**Figures 17, 18, 19**). The Pumping Station comprised an Engine House at the north part of the building, a Coal House at the south, and a Boiler House in the center. Large objects in the incoming effluent that were likely to damage the pumps were removed at the Gate House/Filth Hoist, just to the west of the Pumping Station. The Gate House/Filth Hoist contained a set of four minor engines and pumps for raising and lowering the filth cages inside, as well as gates that controlled the flow of sewage into the Pumping Station.
