43 BOWDOIN ST

43 Bowdoin St, Boston MA

Boston Landmarks Commission

PROJECT DESCRIPTION:
THE PROPOSED WORK IS TO ADD AN AIR INTAKE VENT
IN THE EXTERIOR ENTRY ALCOVE, TO SERVE THE
BUILDING MECHANICAL ROOM WHICH CURRENTLY
LACKS MAKEUP AIR. DUE TO VERY LOW CEILINGS AND
OBSTRUCTIONS BY STRUCTURE AND MEP SYSTEMS,
THE REAR FACADE IS NOT VIABLE

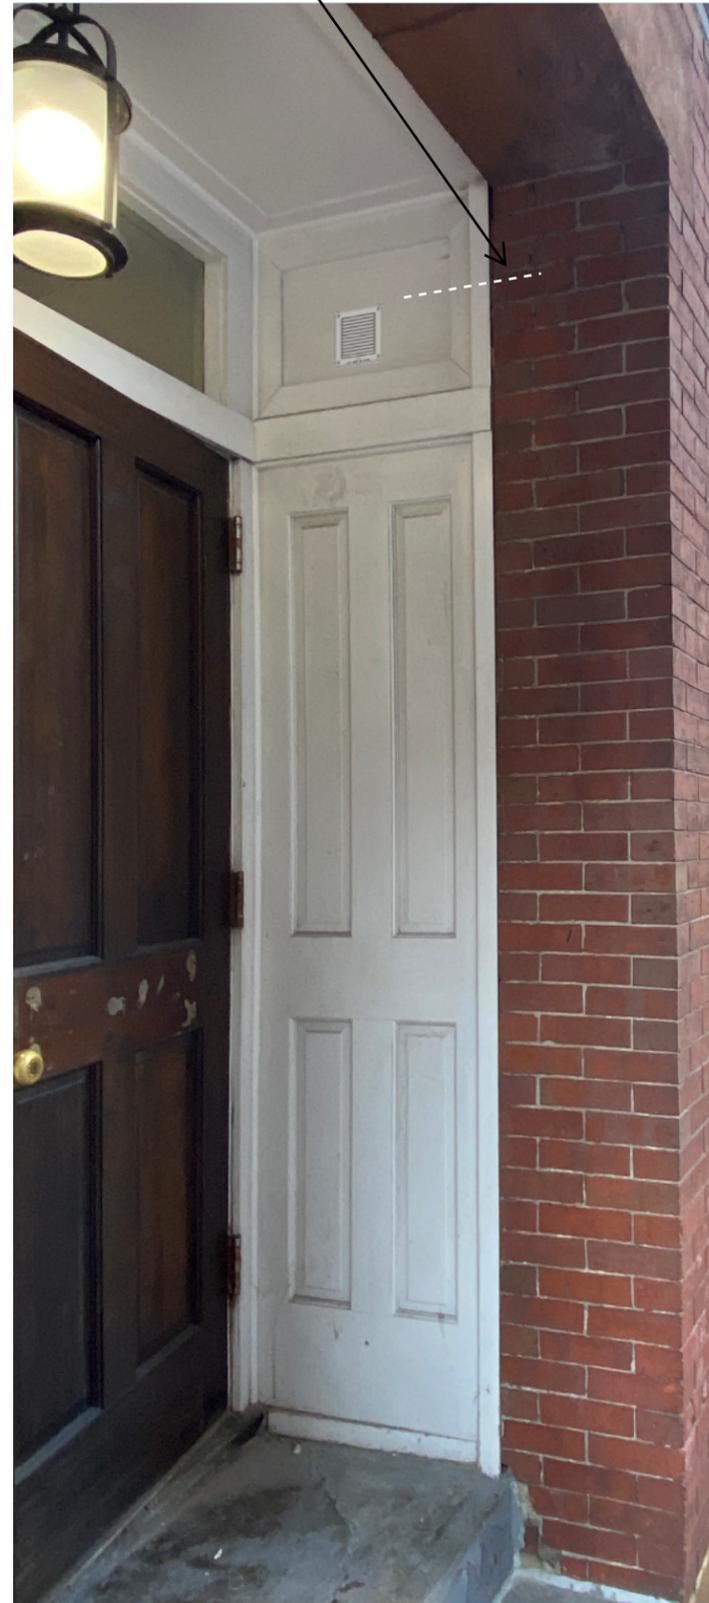
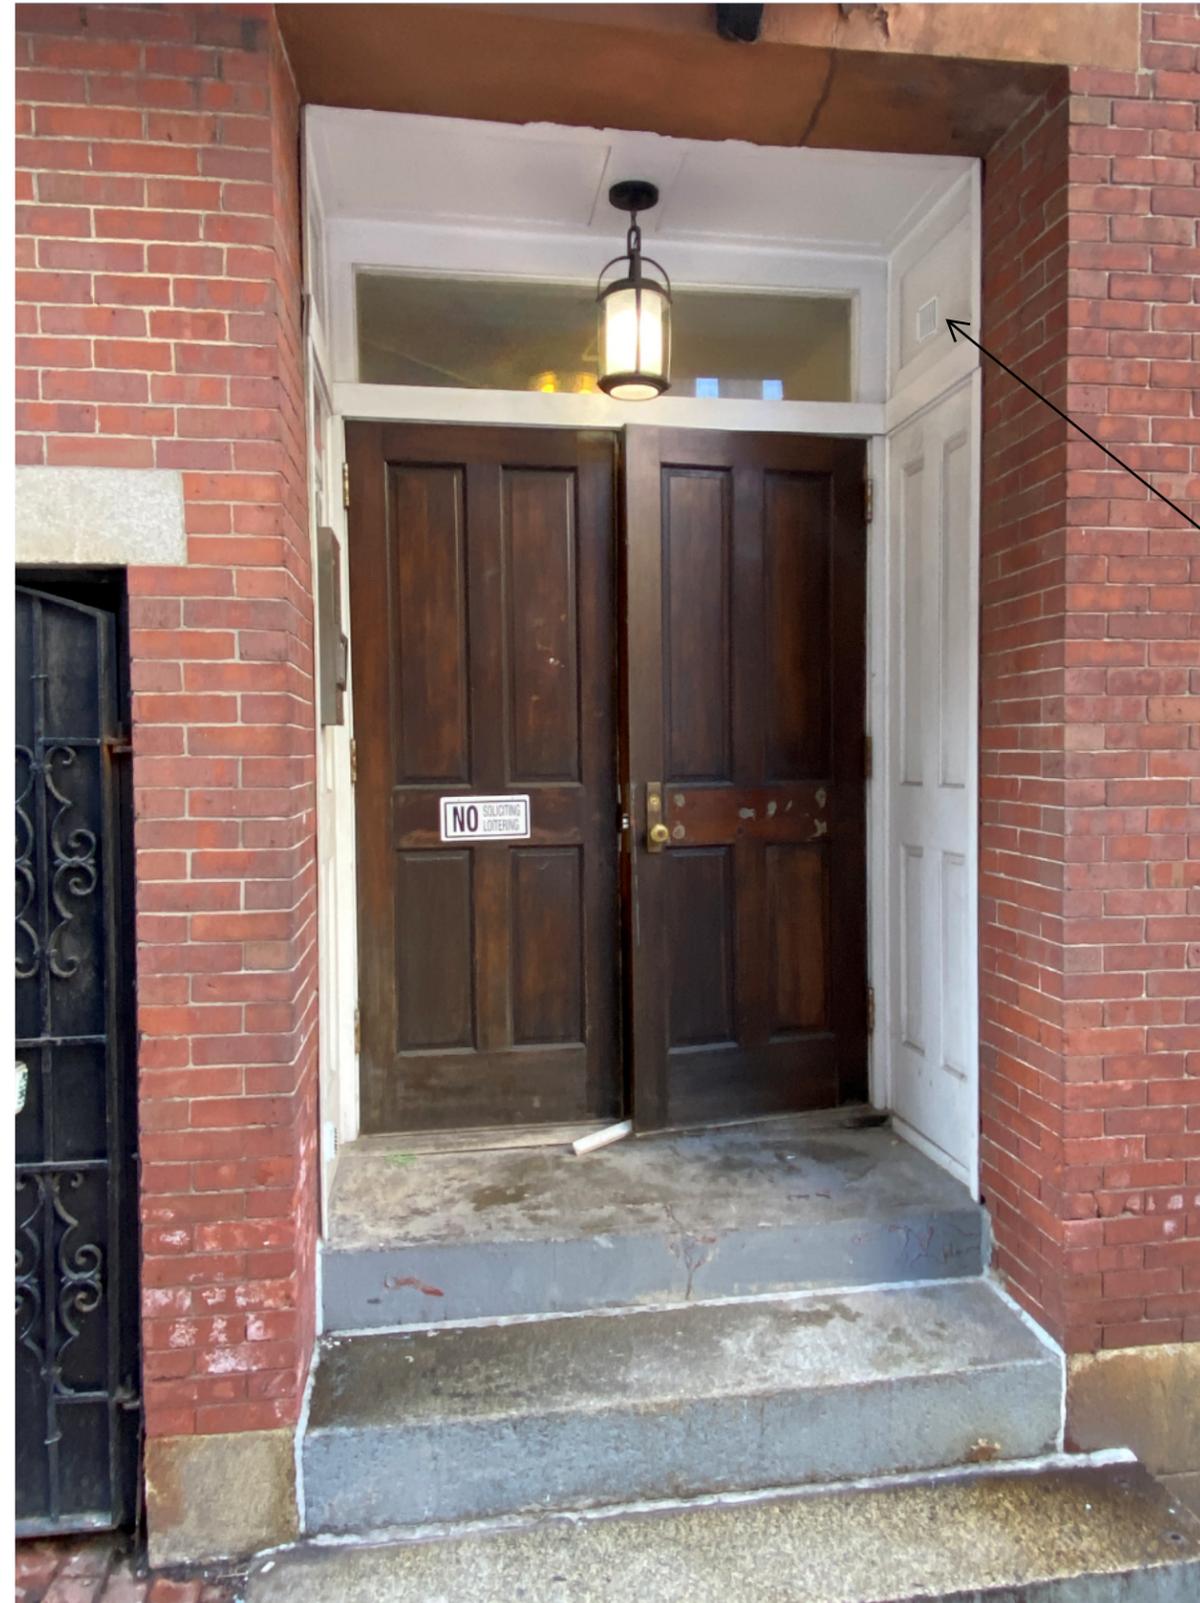
Views of Proposed Entry Alcove
43 Bowdoin St, Boston MA

THE PROPOSED WORK IS TO ADD A 6"X6" AIR INTAKE VENT TO SERVE THE BUILDING MECHANICAL ROOM WHICH CURRENTLY LACKS MAKEUP AIR. DUE TO VERY LOW CEILINGS AND OBSTRUCTIONS BY STRUCTURE AND MEP SYSTEMS, THE REAR FACADE IS NOT VIABLE.

THE GRILLE WILL BE PAINTED TO MATCH EXISTING WOOD PANELING TO REDUCE VISIBILITY
